EXPERT OPINION

Assessment of the Environmental Impact Assessment (EIA) of the Proposed
Renovation and Development of the Hill View Resort (The Ex Banyan-Tree
Resort), Seychelles

Dr. Ameer Ebrahim

August 2023

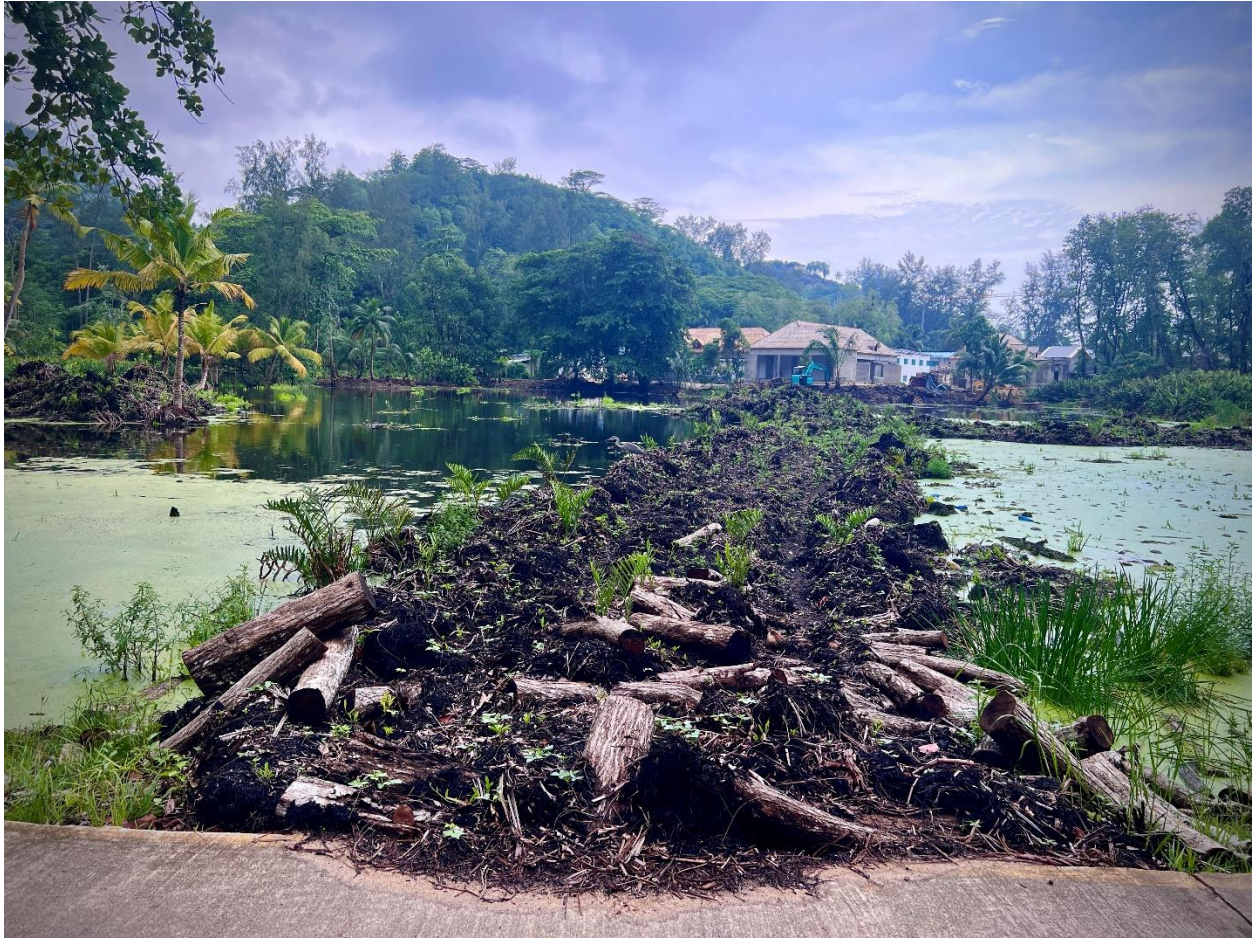
Photo 1: Evidence of dredging activity in the middle of the wetland habitat. Excavator visible in the background (photo taken February 2023)

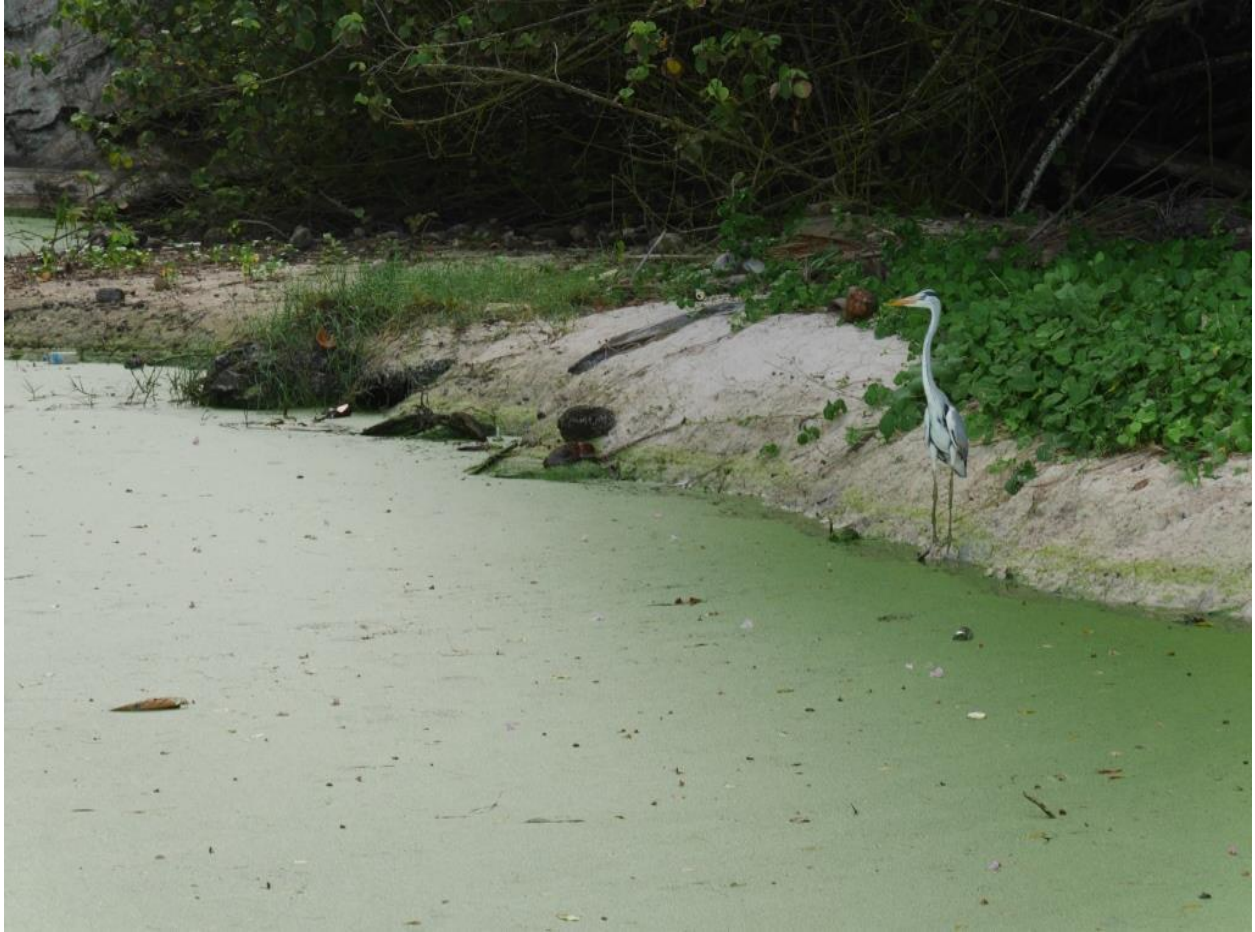
<p>18</p>	<p><i>Page 160</i></p> <p>7.3.1 Wetland</p>	<p>-No development work should take place in the wetland and a protective buffer zone should be delineated to protect the area and species from any impacts from development in the terrestrial areas of the site.</p> <p>-If wetland rehabilitation work is to be carried out, all terrapins must first be trapped and translocated to a suitable temporary habitat in order to mitigate against any potential disturbance of or harm to terrapins.</p>	<p>After speaking with MCSS CEO, no terrapins were caught/ trapped prior to development work.</p>
<p>19</p>	<p><i>Page 162</i></p> <p>7.3.4 Invasive species control</p>	<p>-Mechanical removal of both water hyacinth and duckweeds should be undertaken on a weekly basis for the first 6 months and on a monthly basis thereafter.</p> <p>-Removal of duckweed in smaller ponds can be performed using fine-mesh nets to remove the floating plants....</p>	<p>It is highly unlikely that this has been taking place. The duckweed has completely overgrown on the surface of the wetland (Appendix 3, Photos 2, 3, 4, 5 & 6).</p>

Photo 3: Evidence of significant eutrophication in the wetland (photo taken June 2023)

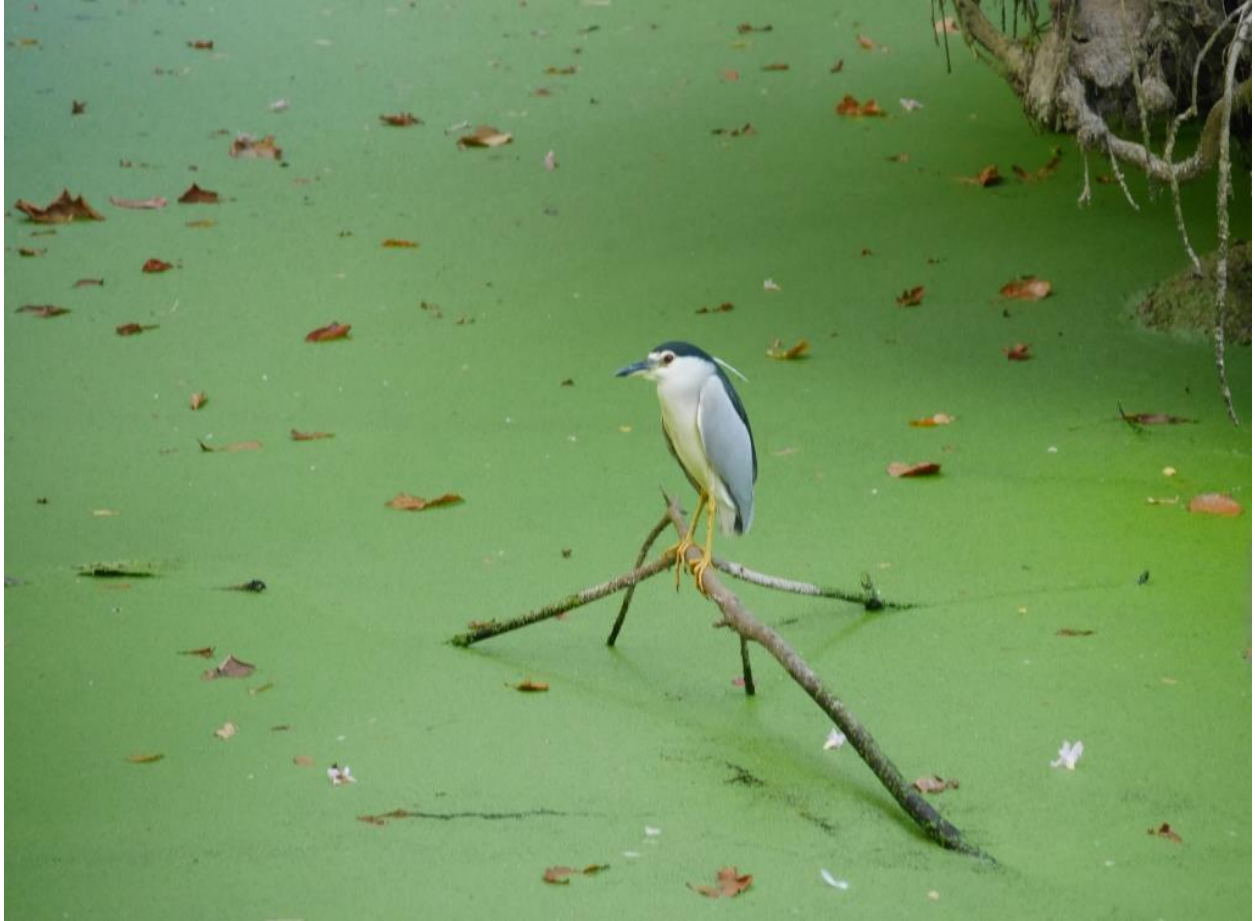
Photo 4: Evidence of significant eutrophication in the wetland (photo taken June 2023)

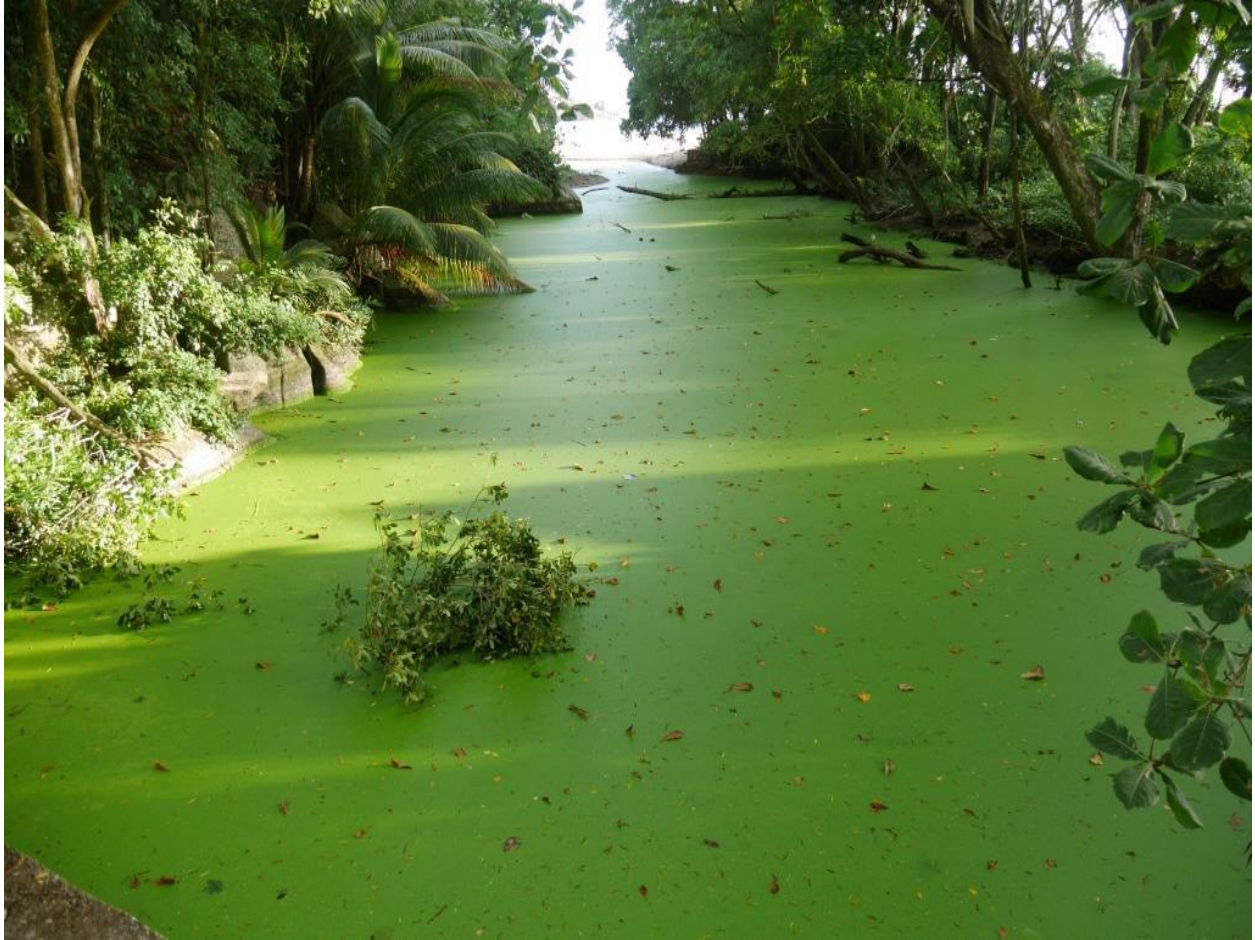
Photo 5: Evidence of significant eutrophication in the wetland (photo taken June 2023)

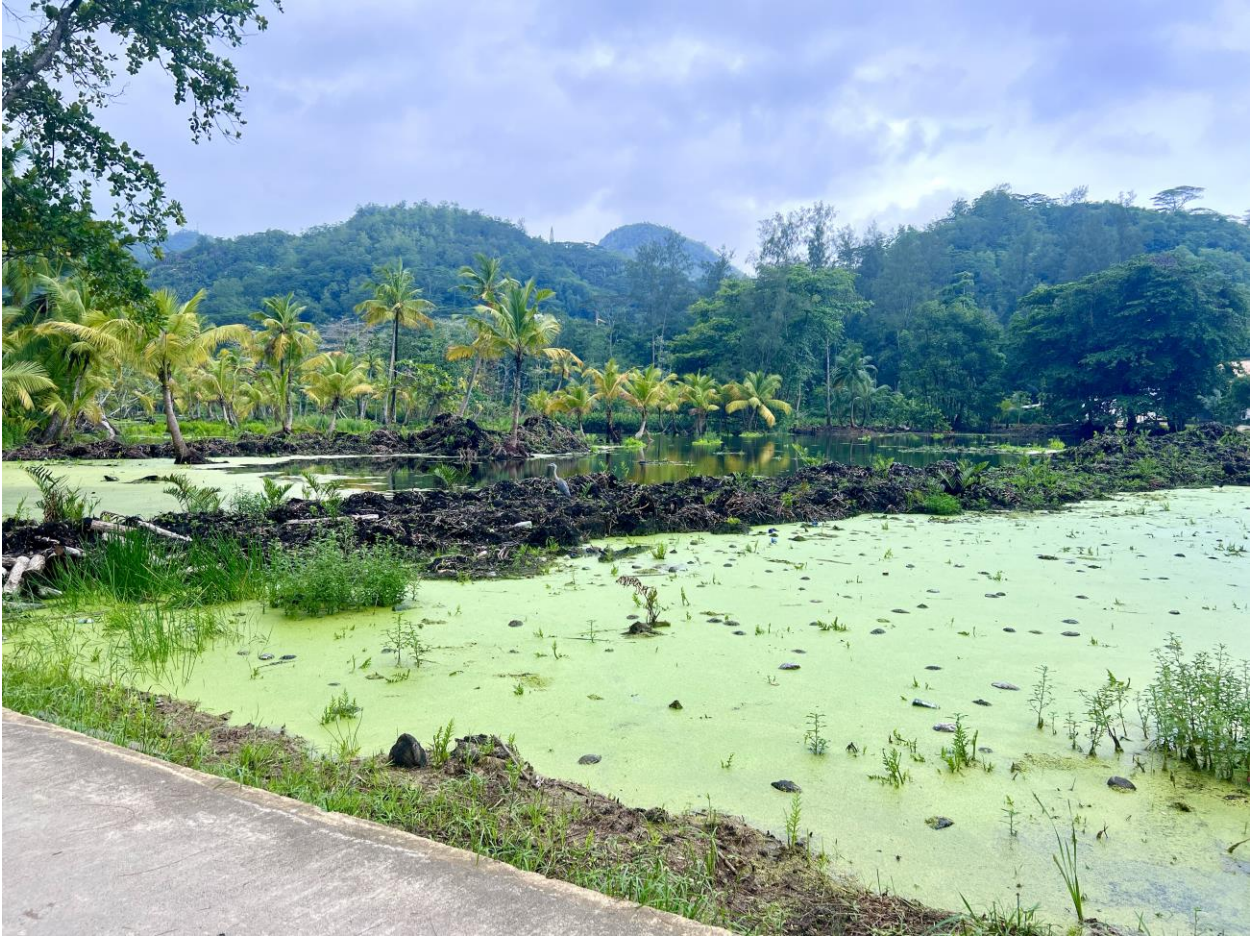
Photo 6: Evidence of significant eutrophication in the wetland (photo taken February 2023)

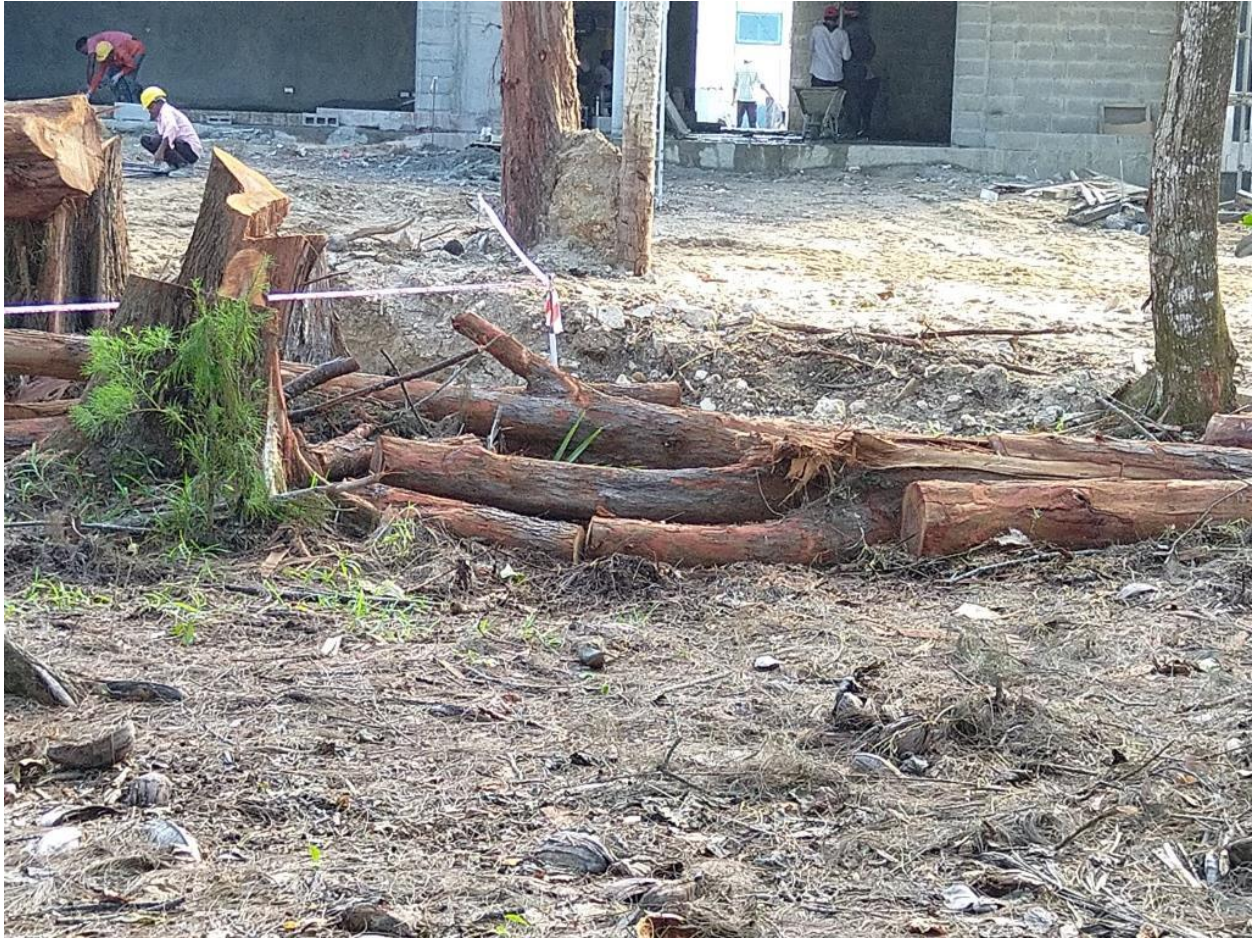
Photo 1: Cutting of trees outside of owner villas (Photo taken in February 2023)

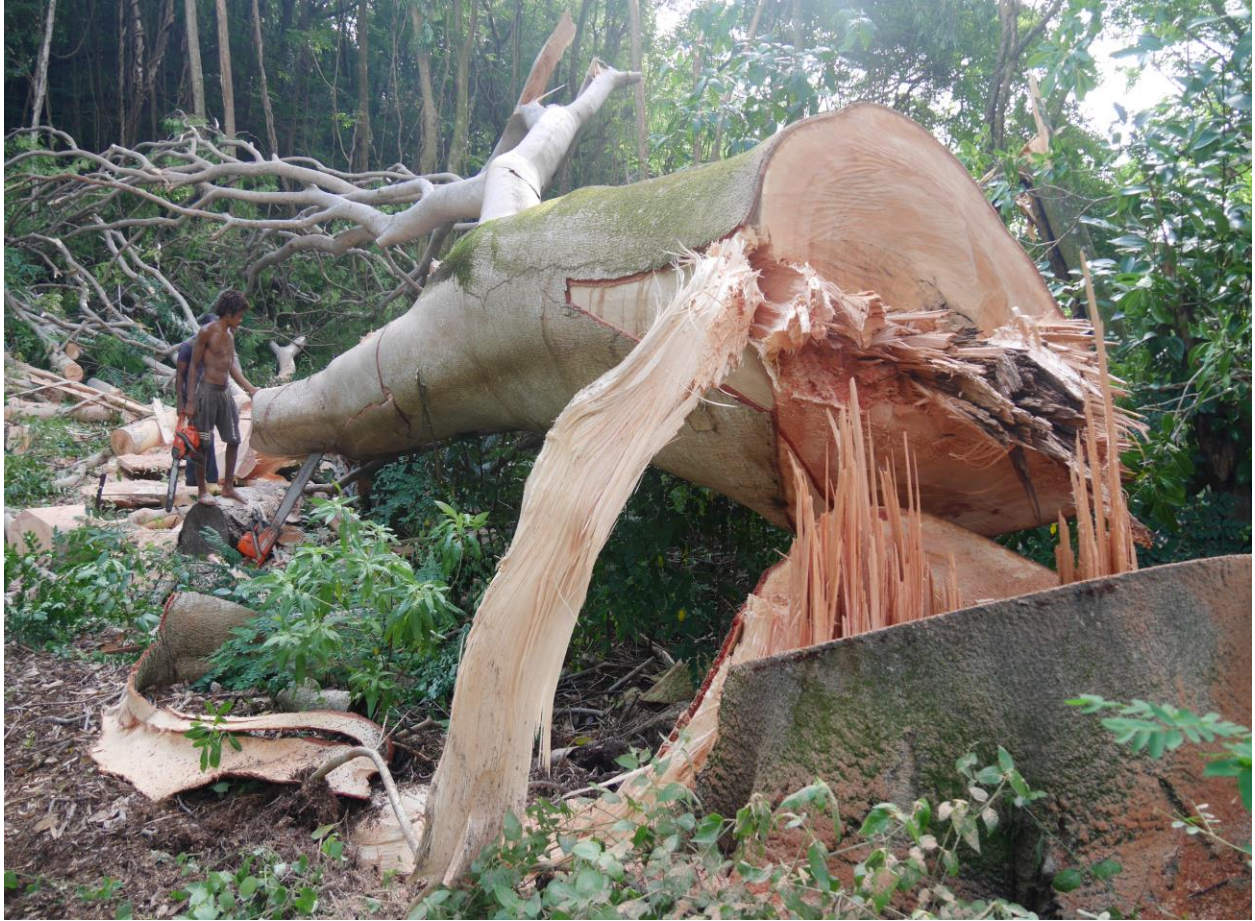
Photo 2: Cutting of a large tree (Photo taken in May 2023)

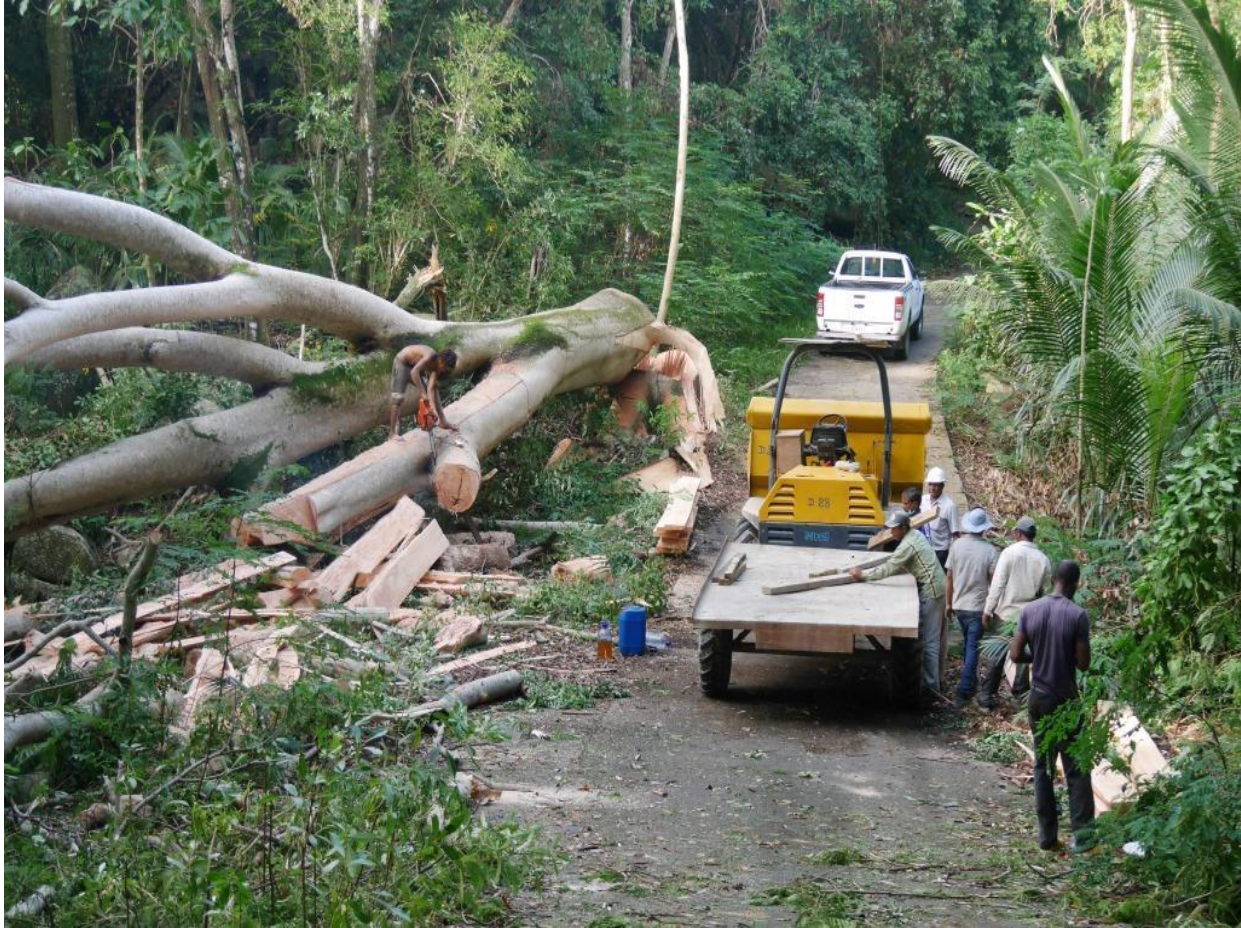
Photo 3: Tree cutting occurring near the main access road to Mr. Karl Ammann's Residence (Photo taken in May 2023)

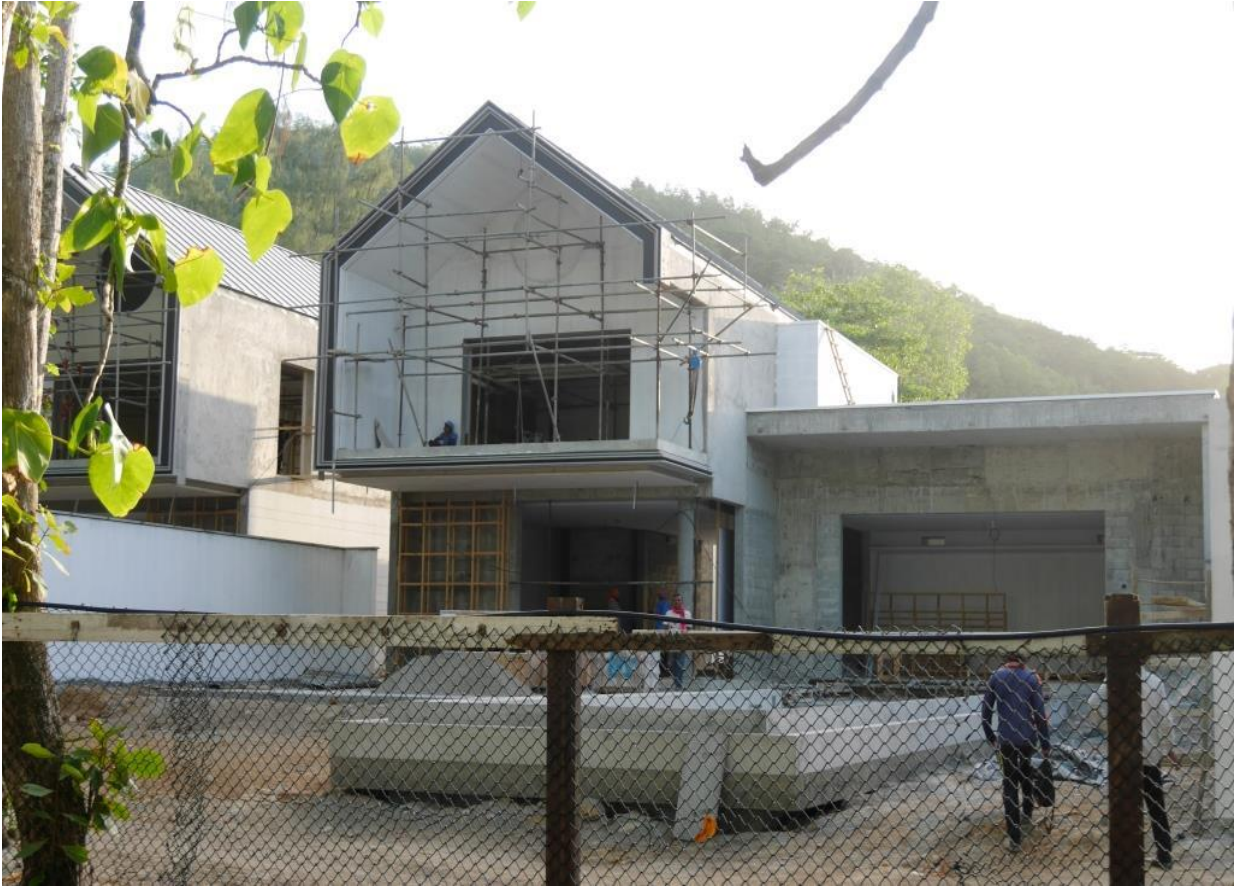
Photo 1: An additional floor seems to be added to the original 2-bedroom beach villas (Photo taken June 2023)

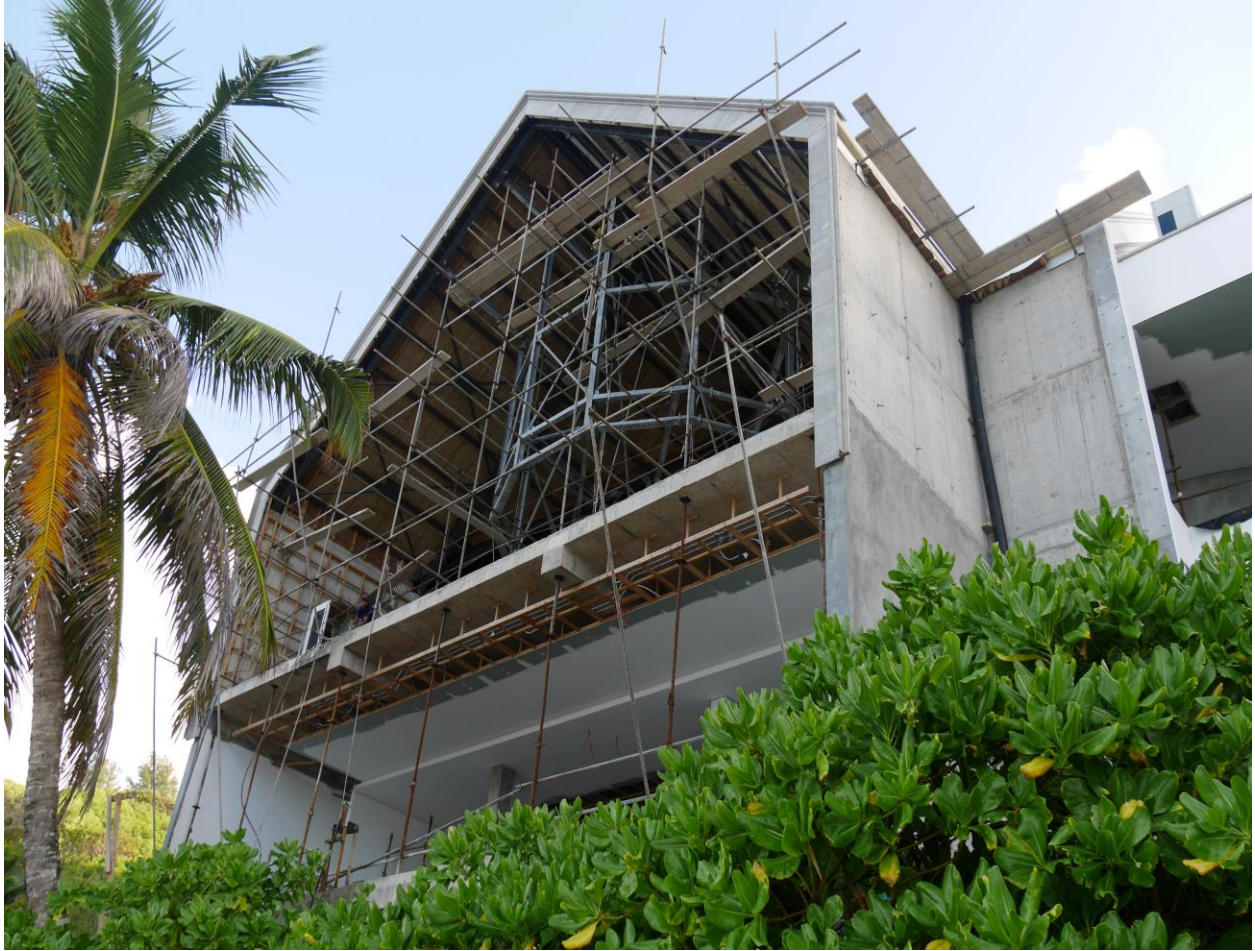
Photo 2: Main lodge seems to have additional height added to the existing structure

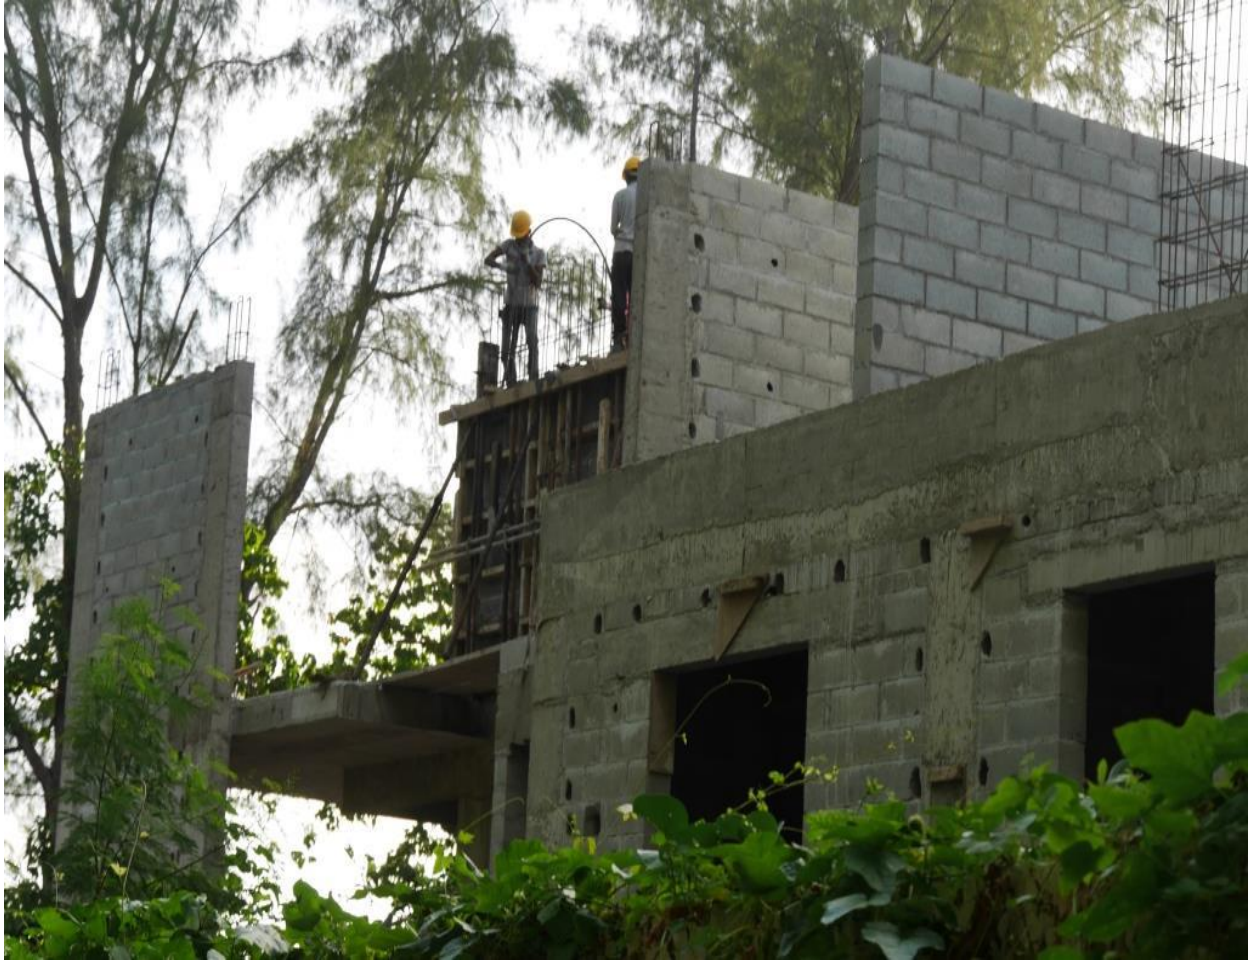
Photo 3: Indication that a third level is being added to the owners Villa (Photo taken June 2023)

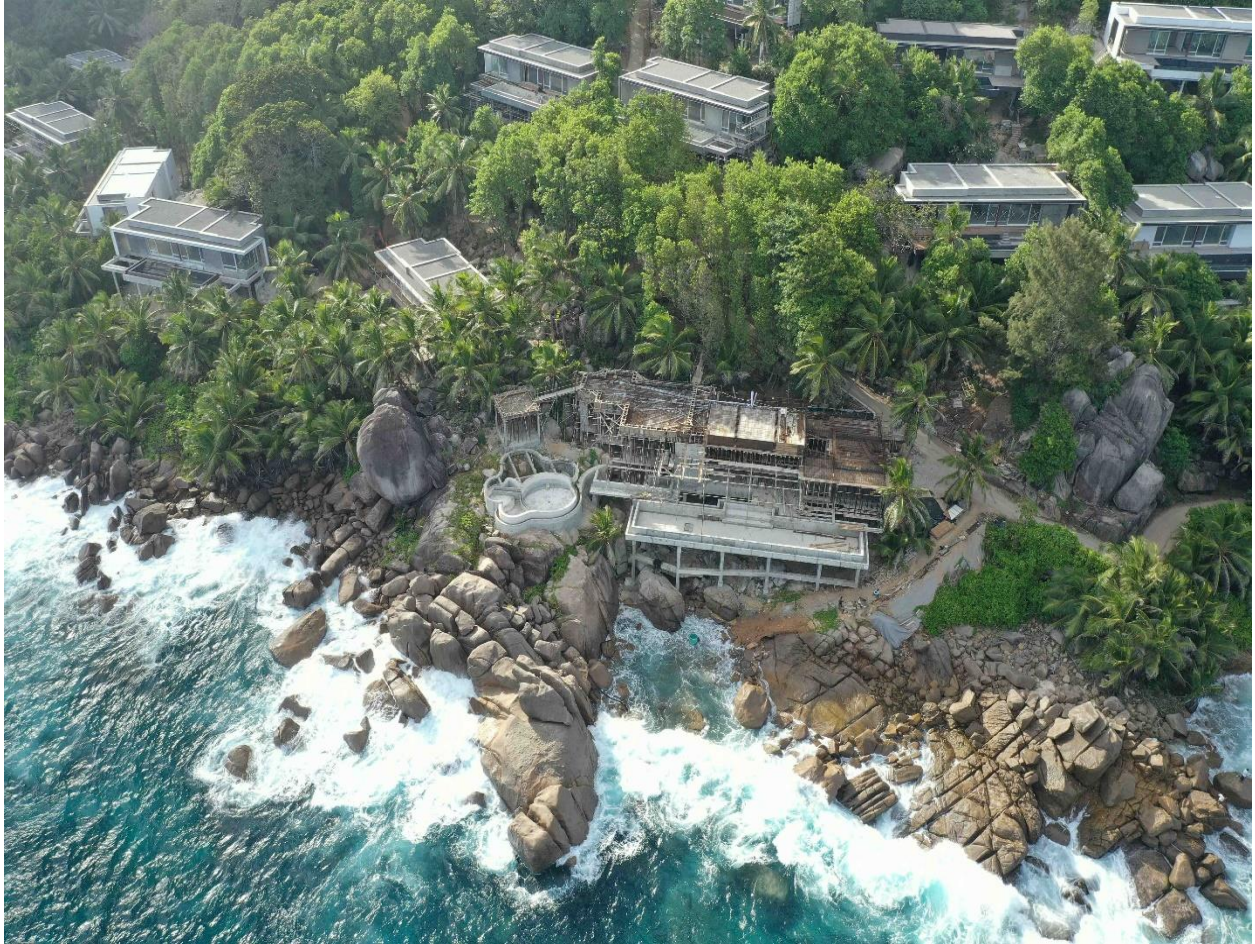
Photo 4: The construction of a new structure next to the swimming pool attached to the former Presidential Villa (Photo taken June 2023)

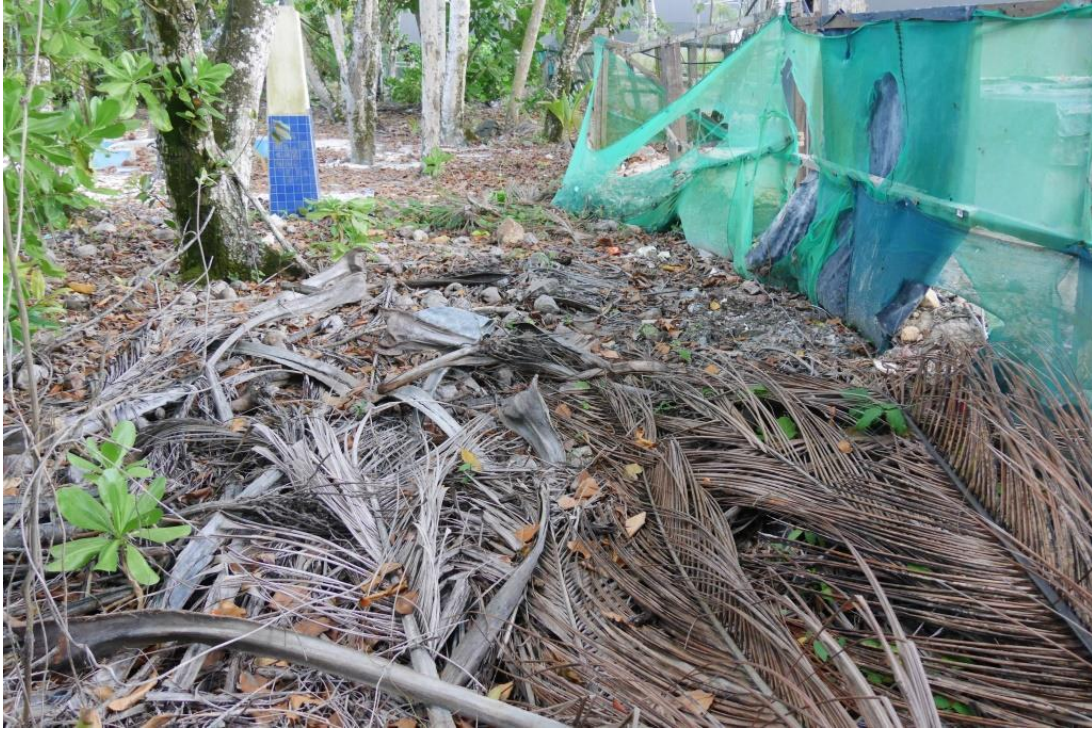
Photo 5: Green fencing erected along the beach villas

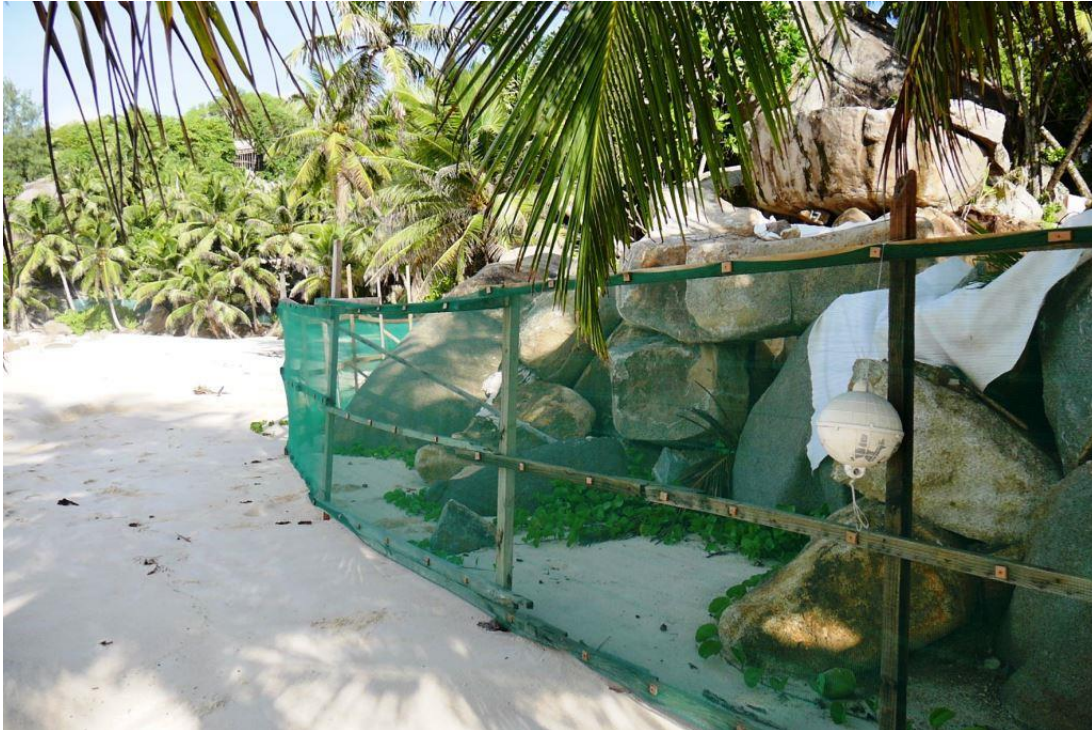
Photo 6: Green fencing erected along the coastline

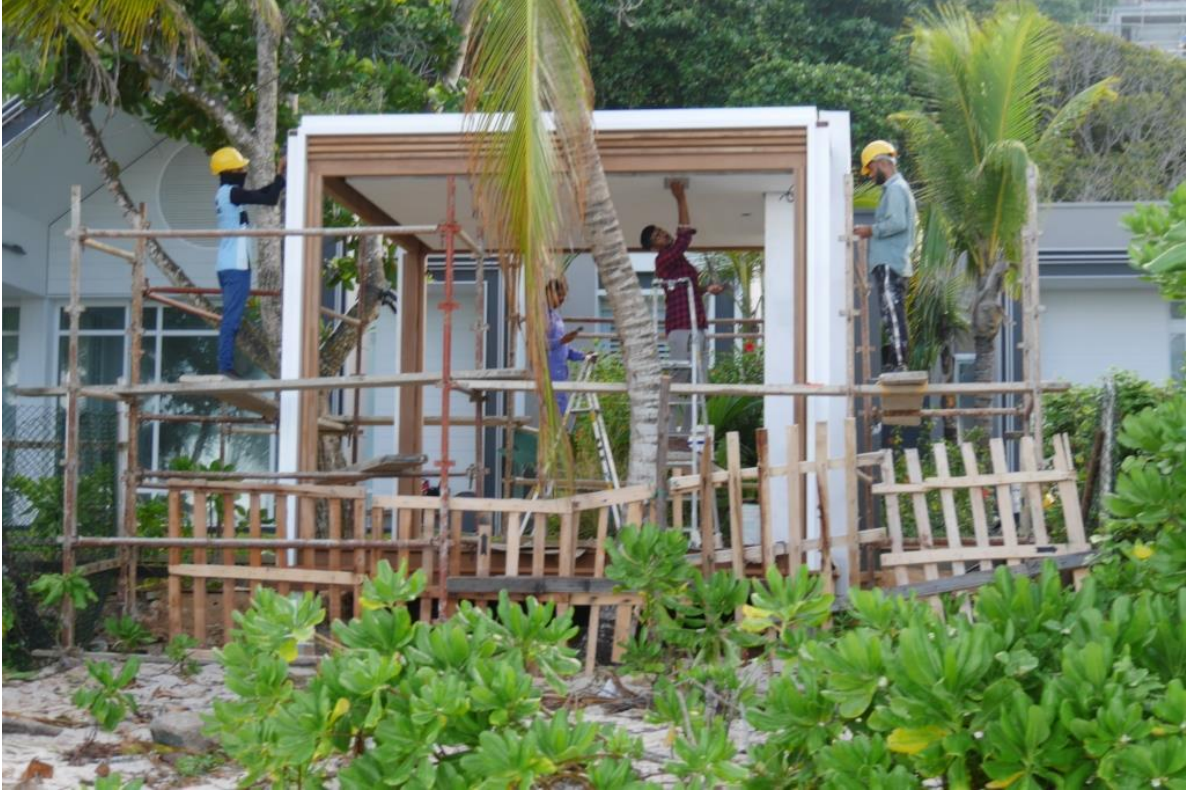
Photo 7: Assumed to be a new dining area in front of one of the beach villas.

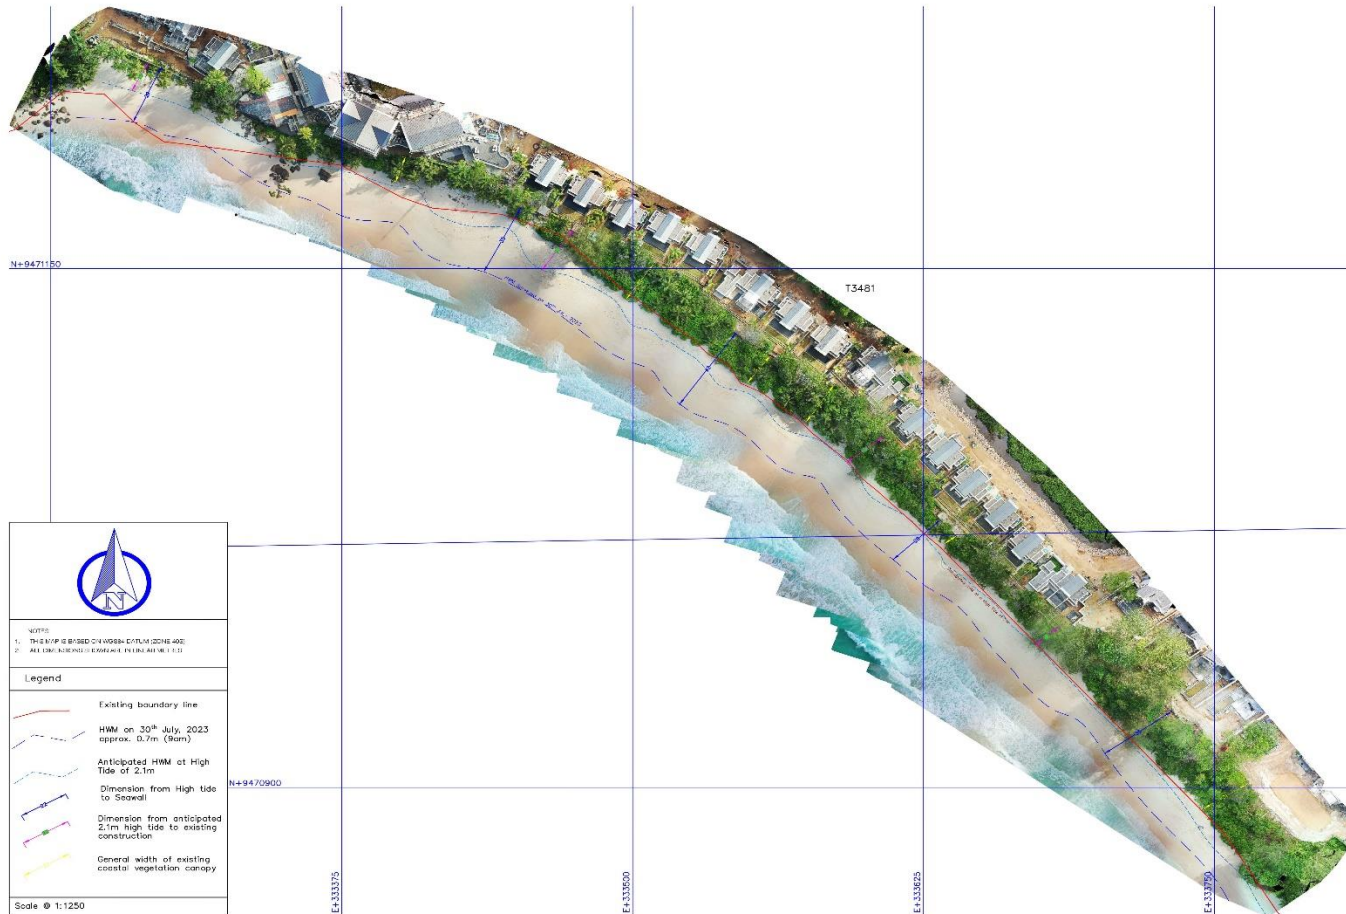
Appendix 9: Recent (late July-August 2023) Drone surveillance (High Resolution file attached separately)

Blue arrowed lines: Highlights the distance from the 0.7m Highwater mark on July 30th, 2023, at approximately 0900, to the closest point of construction.
