# Winterthur/University of Delaware Program in Art Conservation

## Conservation Examination Report and Treatment Proposal

**Owner:** Winterthur Museum, Garden & Library  
**Accession #:** 1965.2058  
**Object:** Clay Pipe  
**Artist/Maker:** Zenith Plateelbakkerij en Pijpenfabriek (Zenith Delftware Pottery and Pipe Factory)  
**Object Date:** 1934-1955  
**Materials:** Earthenware  
**Dimensions:** 16 ¾ x 1 ⅛ x 3 ¼ in. (l x w x h)

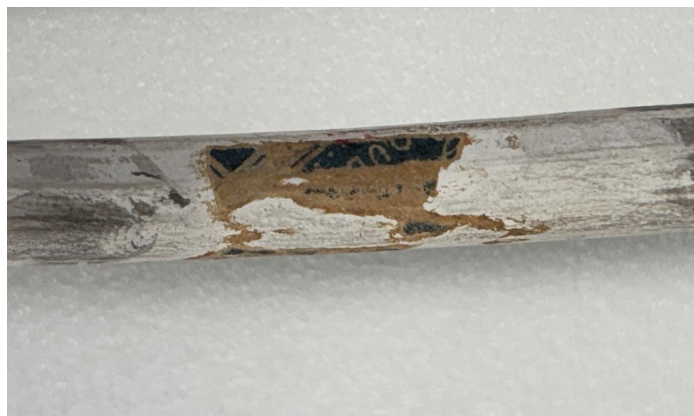
Figure 2. Paper band fragment, stem.

the site of the manufacturer's label (Porell 2016, 4). The paper band is extremely abraded and most of the material is lost.

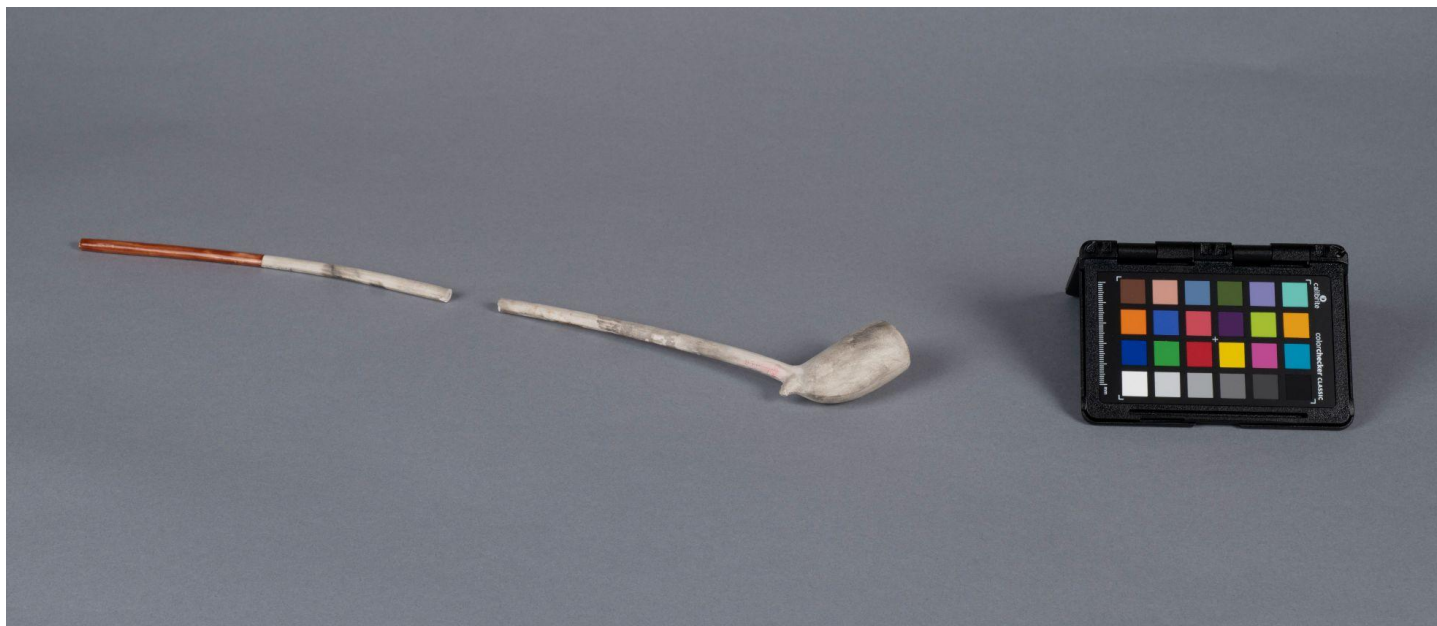
Figure 4. Overall before treatment, normal illumination.<sup>3</sup>

*This pipe is structurally stable but in aesthetically poor condition: a break separates the pipe into two components of nearly equal length. These components realign evenly, but some original material has been lost around the friable break edge, with the largest loss on the underside of the stem. There is no "Change in Condition" report from when the damage occurred. A red stain is present on the underside of the stem near the bowl; this is likely old residue from removing an accession number applied without a barrier layer. This area surrounding this stain also appears cleaner than the rest of the pipe exterior. Small red marks are also present on and just below the paper fragment. The brown-orange glaze at the mouthpiece has approximately 20 pinhead-sized chips to the surface, but the overall glaze is stable and in good condition. There is moderate dark soiling on the exterior of the pipe, but the interior is clean. It is possible that black pigment was rubbed onto the pipe, as evidence of abrasion and rubbing is noted on the stem and at*

The two components of the pipe were rejoined with epoxy. Remaining gaps were filled and aesthetic legibility was reestablished with inpainting. Red stains were reduced.

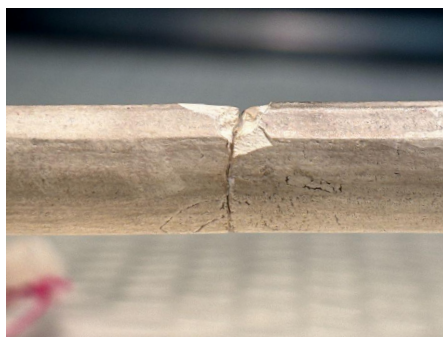
Figure 8. Before fill.

6. Filled gaps at the break edge with Flügger (Talas).<sup>8</sup> Inpainted with Winsor & Newton Watercolors<sup>9</sup> followed by Royal Talens Van Gogh pencils to match the soot on the stem (figs. 8-10) (*3 hours*).

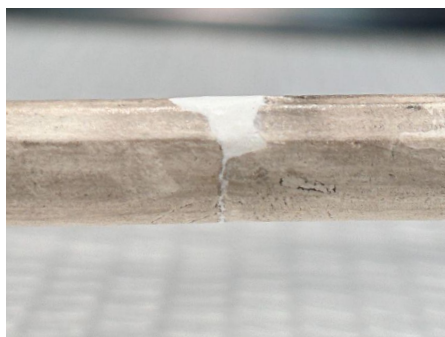
Figure 9. After Flügger fill.

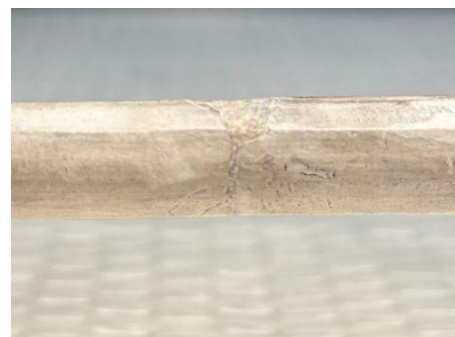
Figure 10. After inpainting.

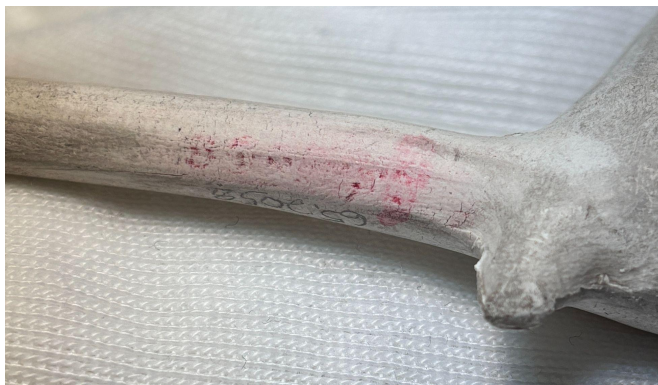
Figure 11. Before stain reduction

7. Reduced the red stain (figs. 11-12) with an acetone poultice applied with Kay-dry tissue (Kimtech) followed by gentle mechanical action with an acetone-swab (*est. 30 minutes*).

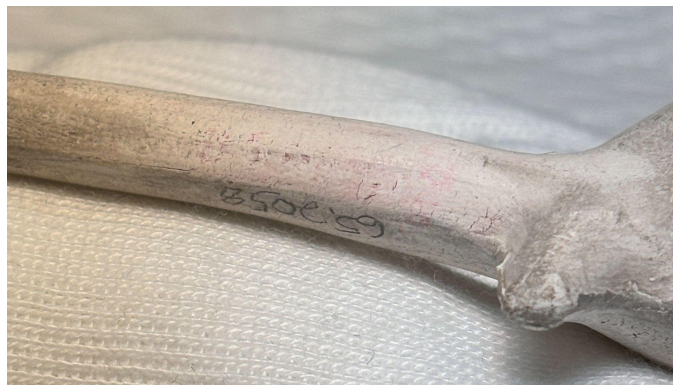
Figure 12. After stain reduction.
