# Winterthur/University of Delaware Program in Art Conservation

## Conservation Examination Report and Treatment Proposal

**Owner:** Winterthur Museum, Garden & Library  
**Accession #:** 2003.0057  
**Object:** Surveying Compass

**Proposal Date:** November 11th, 2024

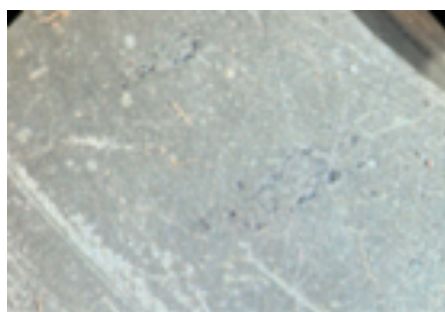
The enclosure for this compass was likely cast then finished on a metal lathe, as evidenced by pitting consistent with casting processes and concentric curvilinear marks on the mount, compass box base, compass box, and compass dial (fig. 9). The extensions were likely cast in one piece and further finished by hand cutting. Single cast components are stronger than mechanical or solder joints (Lauren Fair, personal communication, November 12th, 2024).

Figure 9. Pitting and concentric curvilinear lines. Compass dial near pivot plate, SE-S.

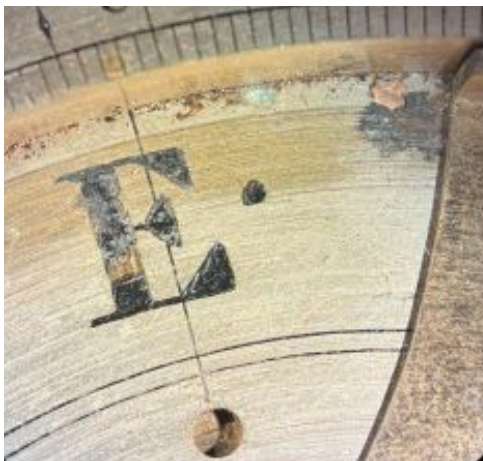
Figure 10. Losses and alligatoring, black infill within engraved text. 250x magnification.

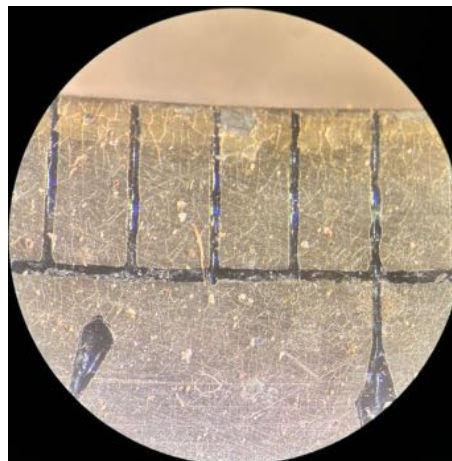
Figure 11. Coating crazing and flaking, raised chapter ring, between NE to E. 400x magnification.

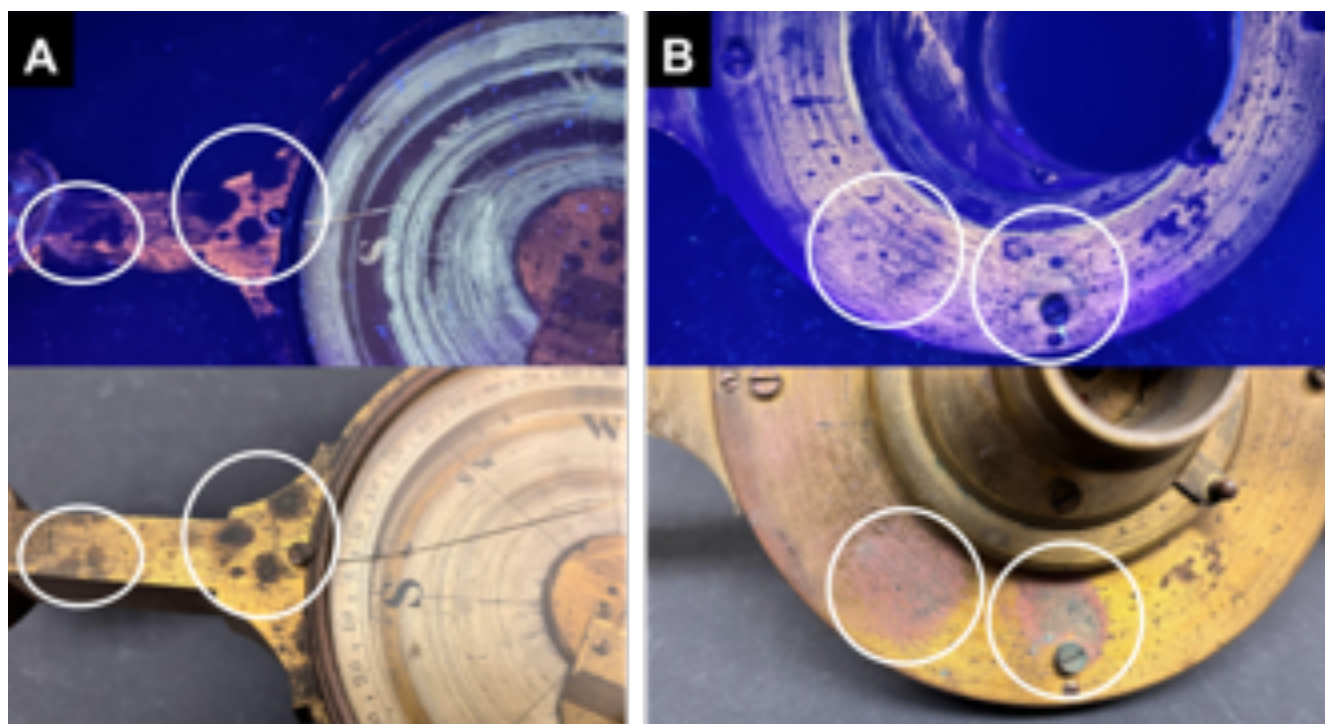
UV examination revealed information on the coatings and materials (fig. 12) (see “Appendix I: Before Treatment Photography” for overall UV images). Under long wave UV (UVA) examination, there are two characteristic fluorescences: the compass dial fluoresces yellow-green and everywhere else is bright orange. This indicates that the compass dial has a different coating than the rest of the compass. Yellow-green is often consistent with a natural resin, and orange is often consistent with shellac. Additionally, there is apparent streakiness in both coatings under UVA, and the corrosion observed is consistent with misses during application or abrasion to the coating. Under ultraviolet short wave (UVB) examination, the surveying compass absorbs all radiation, except for the glass which appears a uniform cloudy yellow (see “Appendix I: Before Treatment Photography” for additional information). The yellowish cast may be related to iron or manganese in the glass, but this is not conclusive; what is conclusive is that the glass is non-lead containing as it would otherwise fluoresce bright blue under UVB (Lauren Fair, personal communication, November 12th, 2024). The incised letters and lines fluoresce bright white due to the binder or a coating.

Figure 12. UVA and visible light comparisons that illustrate regions where corrosion and abrasions correspond to regions of absorption in UV. 12.A depicts larger corrosion patches, and 12.B depicts more mottled areas of corrosion.<sup>3</sup>

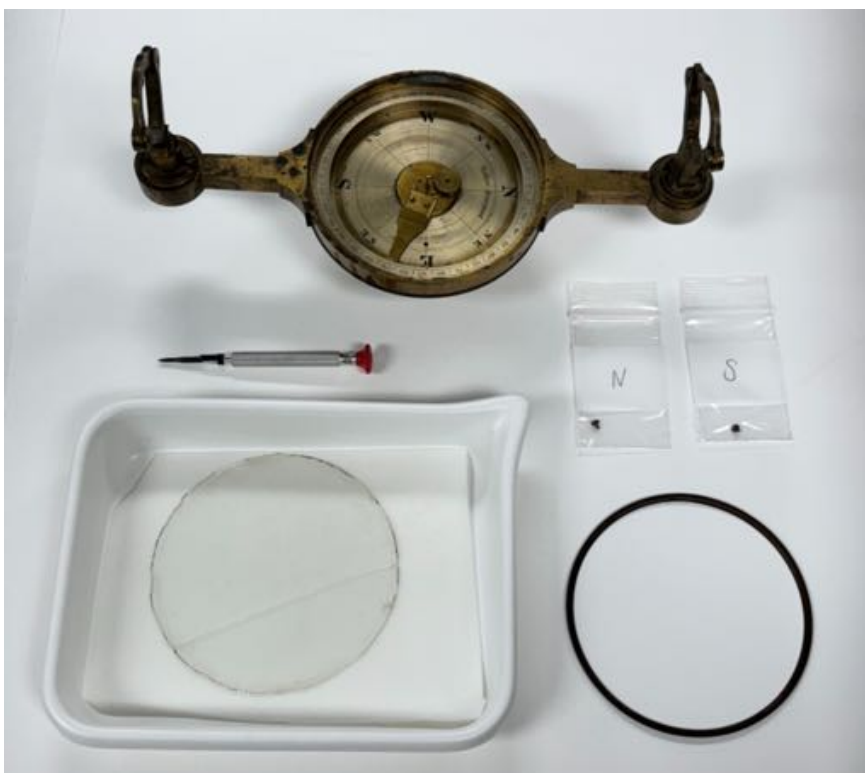
Figure 13. Cover glass removed and components separated.

1. **Carried out pre-treatment examination and photo documentation** (5 hours).
2. **Removed the cover glass for access to the compass dial during analysis and treatment** (0.25 hours).
  - This was completed by removing the two screws with a small flathead screwdriver, distinguishing which screw was associated with the north and south ends (fig. 13). I covered the tip of the screwdriver with painters tape to avoid scratching any metal surfaces. I removed the cover glass border and then the cover glass lifted from the recessed lip.

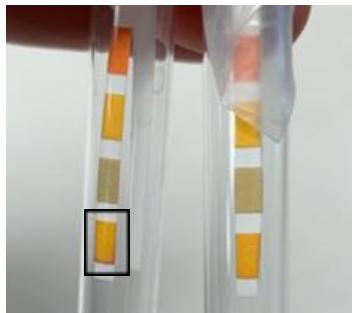
- **Silver nitrate<sup>4</sup> and sulfuric acid<sup>5</sup> spot tests:** these microchemical spot tests resulted in faint positives, confirming the powdery green corrosion on the compass contained chloride ions. This is consistent with active chloride corrosion products. These tests were performed with the guidance of Lauren Fair (figs. 14-15).

Figure 14. Faint positive silver nitrate spot test result indicated by dark red border of the lower square (left) when compared to the negative control (right).

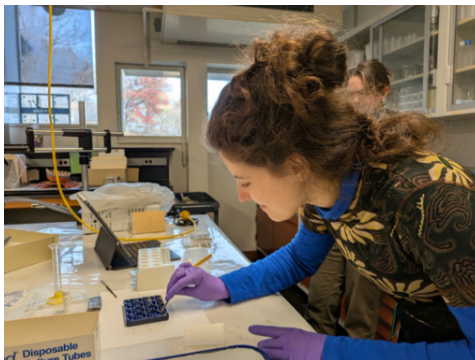
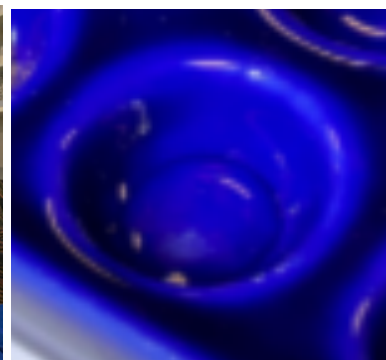
Figure 15. Conducting sulfuric acid spot test (left). Faint white results after the test was completed (right) indicated a positive test for chlorides.

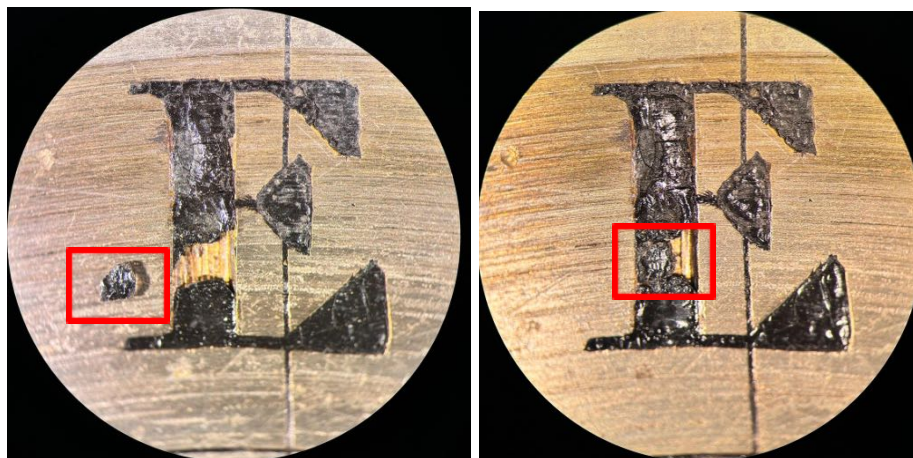
Figure 17. Before (left) and after (right) consolidating and reattaching the inlaid colorant fragment.

- **Solvent tests:** I conducted solvent testing to inform consolidant selection. Shellsol D-38, acetone, and ethanol all penetrated quickly with no discernible change in condition.
- **Consolidated and reattached fragment:** Once the cover glass was removed, I identified a fragment of the inlay among the loose soil particles on the compass dial. After applying a 5% Regalrez 1094<sup>6</sup> in Shellsol D-38<sup>7</sup> barrier layer, I reattached the fragment to the “E” with 40% Paraloid B-72<sup>8</sup> in acetone (fig. 17). The other letters were stable and no further stabilization was necessary.

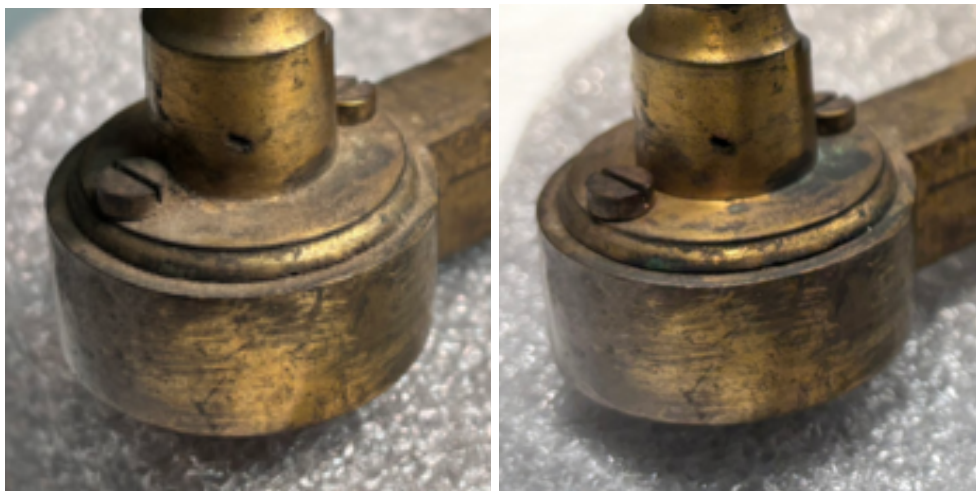
Figure 19. Detail of the south end instrument attachment arm before (left) and after (right) solvent cleaning.

- Then, I overall surface cleaned the compass enclosure, compass dial, and cover glass border with Shellsol D-38 applied with a swab and cosmetic sponge. Once embedded soiling was removed, light green corrosion products were less evident (fig. 19).

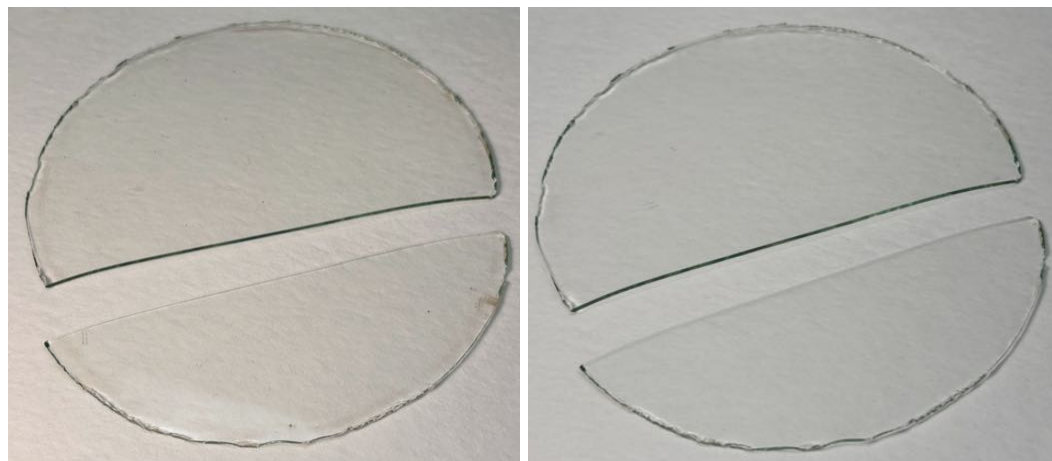
Figure 20. Before (left) and after (right) solvent cleaning the cover glass.

- Lastly, I surface cleaned the cover glass with 1:1 ethanol and deionized water with a Kimwipe<sup>9</sup> and dried with a microfiber cloth<sup>10</sup> (fig. 20).

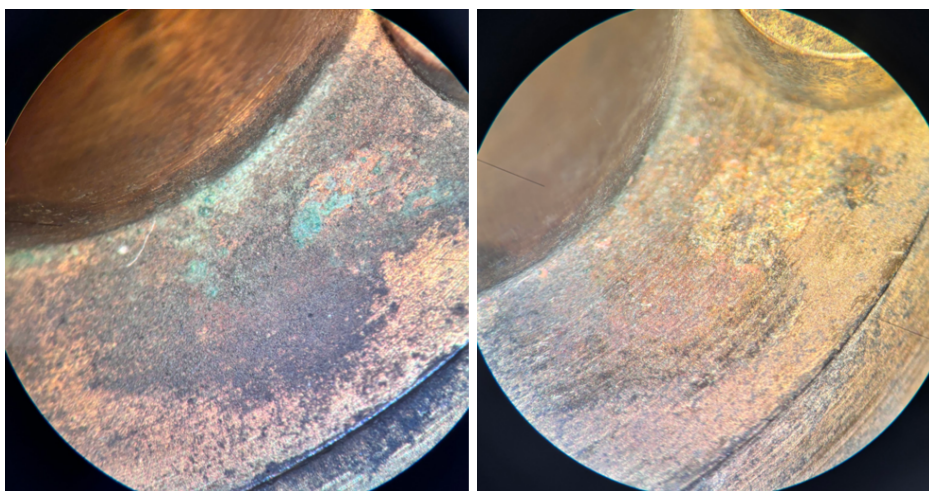
Figure 21. Detail of Figure 19 before (left) and after (right) mechanical corrosion reduction.

- **Mechanical:** With a scalpel, insect pin, and Shellsol D-38, I significantly reduced most areas of corrosion and achieved flat smooth surfaces (fig. 21). I further reduced corrosion locally with 0.3 micron alpha alumina Buehler micro polish<sup>11</sup> with 1:1 ethanol and DI water, cleared with 1:1 ethanol and DI water. The goal of this step was to reduce the visual prominence of corrosion products and maintain the original

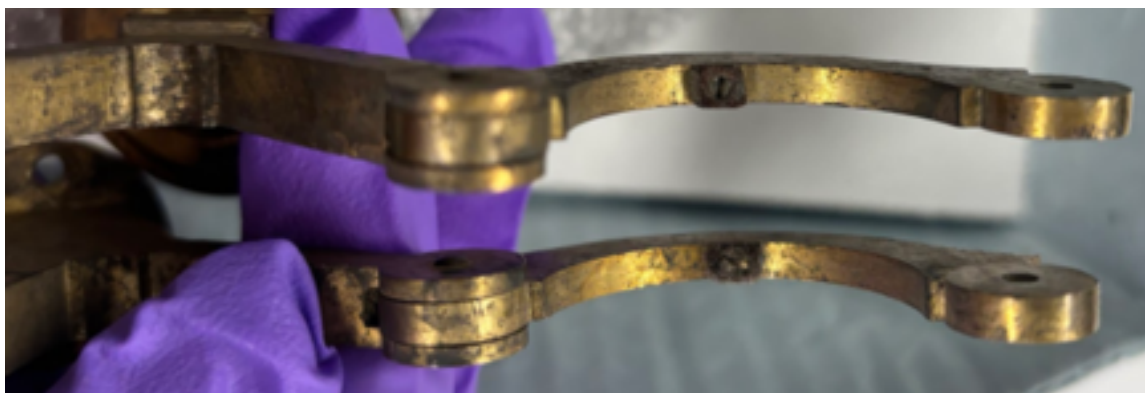
Figure 22. Original instrument holder pad (top) and replacement (bottom).

- **Instrument holder pad, north end:** I cut a replacement pad to size from polyester ultrasuede adhered to toned Japanese tissue to imitate the smoother top side and fibrous edges of the leather pad on the south end. I tamped down fibers of the replacement edges with 2% Klucel G<sup>13</sup> in DI water (w/v). I adhered the replacement pad to the underside of the instrument holder hinged component with 15% Paraloid B-48N<sup>14</sup> (w/w) in 98% acetone and 2% ethanol.

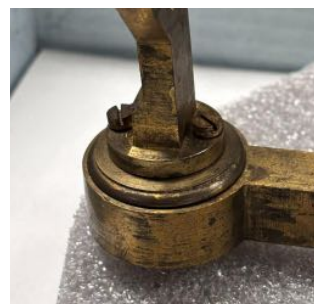
The northern instrument holder and base are missing one screw (type A), which contributes to its unintentional ability to swivel on the attachment arm. The one intact screw is slightly raised and does not create sufficient structural support to hold the components in line with friction and pressure.

Figure 30. Replacement screw in place (right side), north instrument holder base.

- **Slotted screw type A, north end:** I created a replacement screw with the guidance of Kate Jennings, Metals Subject Leader in the Conservation Studies Program at West Dean College, and Lauren Fair. 18-gauge brass rod was thinned slightly by periodically annealing and drawing the rod through #1 on ART 110 draw plate for the screw body (fig. 23). I threaded the screw with a 6-32 die (fig. 24). To create the head, I cut larger gauge brass to length to match the head of other screws, and then I matched the slot with a hack saw of similar kerf width as the original screw slot width (figs. 25-26). To finish the screw, I soldered the head onto the body with silver brazing solder and flux (fig. 27). Finally, I polished the new screw with Solvol Autosol<sup>15</sup> and steel wool #0000, clearing polishing residues with ethanol (fig. 28). I completed inpainting to the visible screw head with Gamblin Conservation Colors<sup>16</sup> solubilized with 80% isopropanol with 20% petroleum benzene. A final layer of inpainting was completed with a wash of golden fluid acrylics<sup>17</sup> before fitting the screw to the north instrument attachment arm (figs. 29-30).

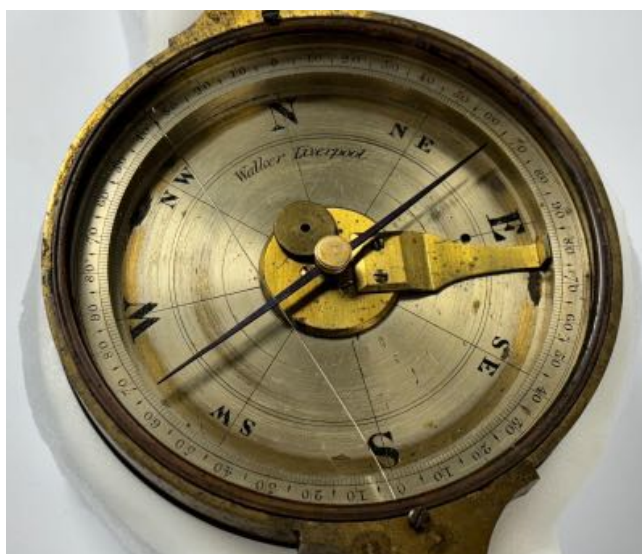
Figure 37. Needle in place, with cover glass reattached.

- **Needle:**<sup>18</sup> Mia Kaplan, metalsmith at Night Shift Studio, fabricated a replacement compass needle based on a design that was approved by Ann Wagner. Refer to “Appendix V: Needle Replacement” for a discussion of what this design and construction should entail. The needle was laser cut from 1008 mild steel<sup>19</sup> based on a digital rendering. The cap of the needle was made from 5/16” diameter Ultra-Machinable 360 brass rod.<sup>20</sup> This cap also incorporated a small sapphire set into the underside; the sapphire was provided by Brittany Cox at Memoria Technica. Mia fabricated the needle from these materials (figs. 31-36). I joined the needle to the needle cap with Epo-Tek® 301-2 epoxy resin.<sup>21</sup> When placed on the pivot, the needle spins freely. However, if tilted, the needle can become slightly askew. I coated the needle with Cosmoloid H-80 microcrystalline wax<sup>22</sup> in Shellsol D-38, buffed slightly. To hold the needle in place long-term, I rolled a small piece of Parafilm M<sup>23</sup> to wrap around the base of the pivot. The needle does not move freely in this arrangement. The needle was not magnetized, but this can be pursued at a later date. Additionally, no “north” marker was pursued at this time, but this can also be added at a later date if desired.
