# ANCHORAGE MUSEUM

## Conservation Examination Report and Treatment Proposal

**Accession #:** 1988.13.1

**Object:** Model, Umiak with Sail

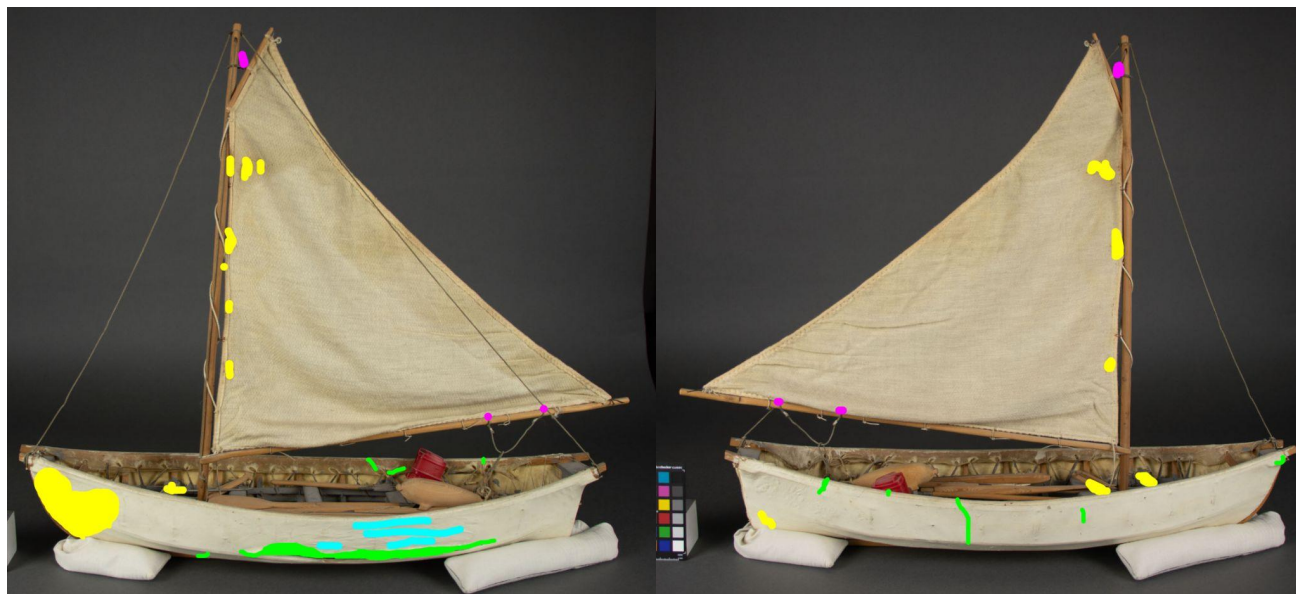
Structurally there are: seven tears on the embrittled hull. There is one large tear on the central PL side: approximately 28 ¼ cm x 1 cm (L x W, overall) that now has a gap due to material fluctuations. There are five tears on the PR side, from bow to stern: 1 x 0.1 cm, 2.1 x 0.1 cm, 9 x 0.3 cm (wraps around the gunwale), 1.5 x 0.1 cm, 1.75 x 0.2 cm (L x W, overall). There is an additional branching tear (3.5 x 2 cm) visible on the interior bow of the hull (figs. 10-11). The hull is brittle. Embrittled marine mammal organs in heritage objects is common, and sometimes deemed preferable, in museum collections (Cruikshank and Sáiz Gómez 2009, 3). The tears have planar deformation along the break edges, with edges curling out on the PL side, and a 2 mm shelf between edges on the longest tear on the PR side. There is a risk of tears lengthening, although comparison to prior photo documentation does not indicate that this has occurred. This brittleness contributes to the necessity of structurally supportive storage housing and minimal handling for this umiak.

Figure 9. Condition diagram. Left: proper left (PL) side, right: proper right (PR) side.

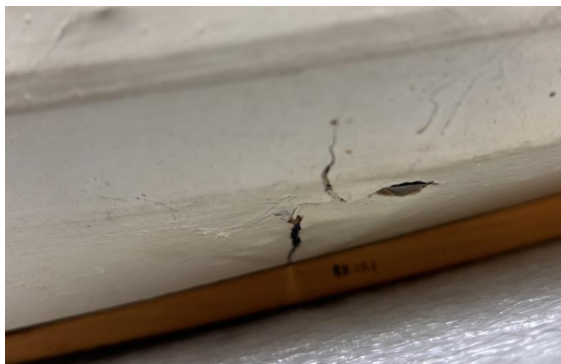
Figure 10. Hull tear (exterior, PL bow) and accession number (keel).

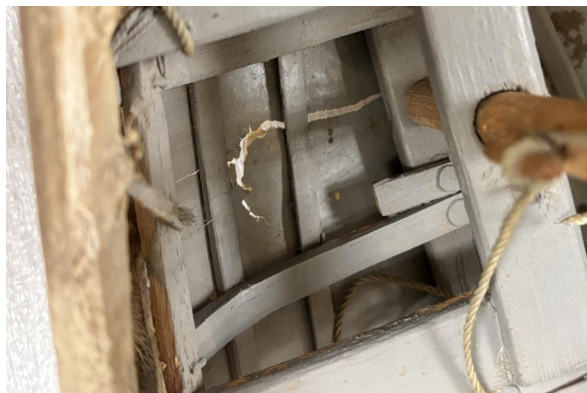
Figure 11. Hull tear (interior, PL bow).

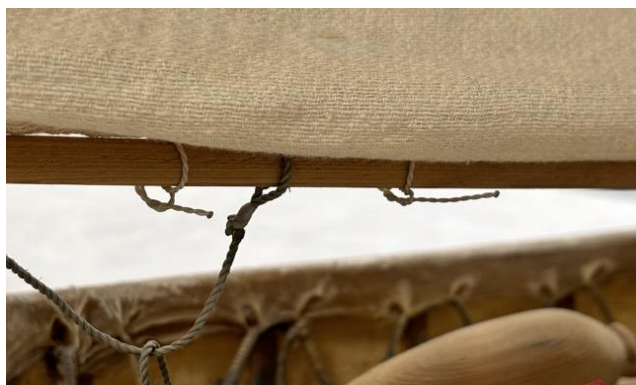
There are additional structural condition characteristics to note. Loose knots that attach the sail to the boom are at risk of unravelling which would result in loss of the original maker's process (fig. 12). The bow seat is at an improper orientation, likely since it shifted off the original nail holding it in place (fig. 13). Additionally, sprung wood on the PL side results in a gap between the outer stringer and side rib that increases the likelihood of the marine mammal organ fluctuating (fig. 14). Paint cracks (tenting) on the hull likely resulted from the tensioned material fluctuating slightly with the absorption and desorption of moisture. There is a 2 cm abrasion and 1 x 0.75 cm area of wrinkled paint on the center thwart (fig 15).

Figure 12. Loose knots that attach the sail to the boom.

1. **Carried out pre-treatment examination and photo documentation (4 hours).**
2. **Tightened and secured ropes (0.25 hours).**
  - Tightened six knots attaching the sail to the boom. Brush applied one pass of 15% Paraloid B-72 in 1:1 acetone and ethanol over the center of the knot (figs. 24-25).

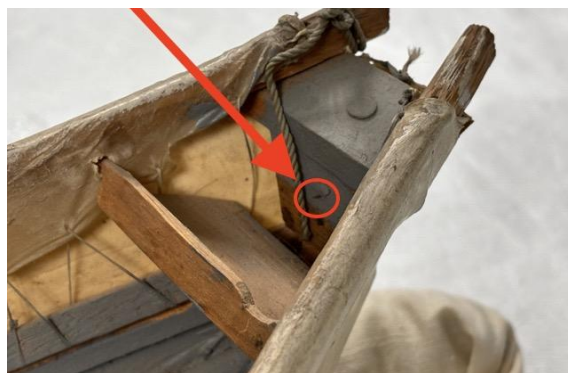
Figure 13. Improperly oriented bow seat. The red circle and arrow point to a pin, likely indicating the original position.

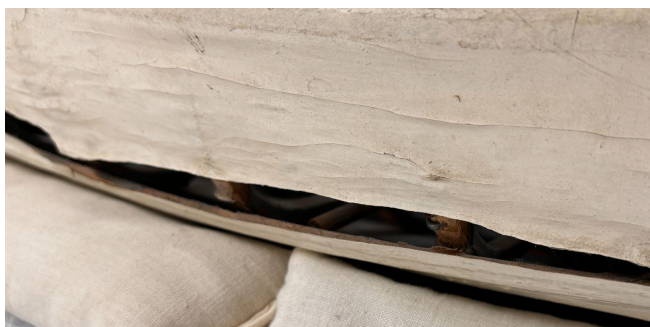
Figure 14. Gap between the outer stringer and side rib, visible through the gap. Longitudinal paint cracks on the PL hull exterior.

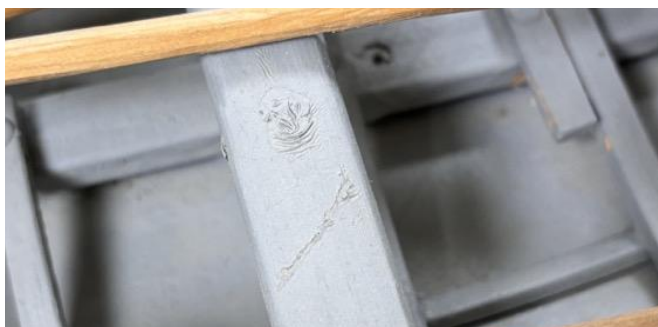
Figure 15. Abrasion and wrinkled paint on the center thwart.

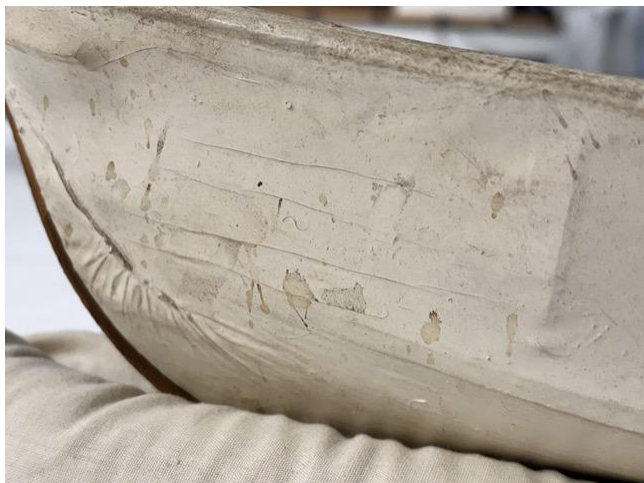
There is moderate surface grime and dark red-brown staining on the model. The staining is located on the bow painted exterior, bow thwart and bow interior, and woven sail (figs. 16-18). Dark accretions and soiling deposits are scattered across the painted exterior hull (fig. 19). These stains and accretions mostly absorb ultraviolet (UV) light.

Figure 16. Staining, PL bow painted exterior.

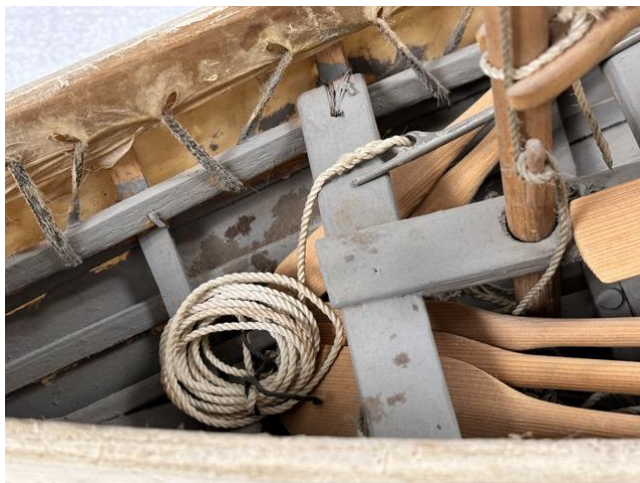
Figure 17. Staining, bow thwart and bow interior.

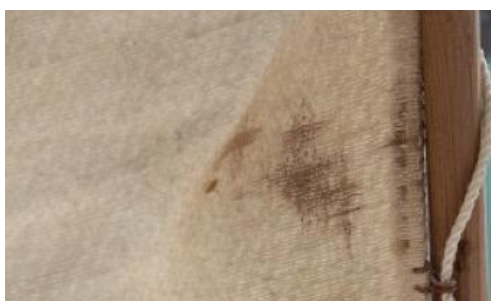
Figure 18. Staining detail, woven sail.

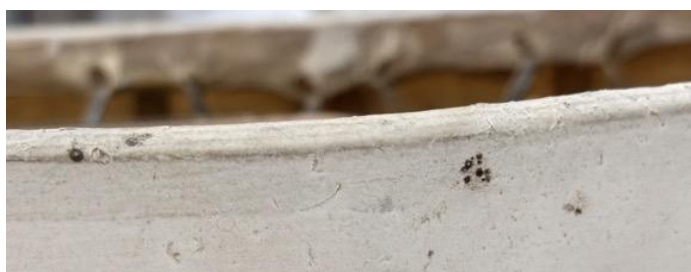
Figure 19. Dark accretions and soiling deposits on the hull exterior.

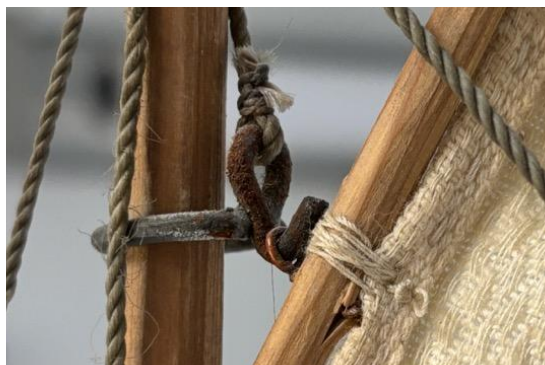
There is also light, compacted corrosion on several of the tools and metal components (figs. 20-22). These corrosion products are white, red, and blue-green. The blue-green, powdery corrosion is more likely to be unstable. The red motor is missing one notch of the mounting bracket which likely snapped off at an unknown point. Both sides of the mounting bracket appear white, likely due to stress-induced embrittlement.

Figure 20. Dark red-brown and white corrosion products, top of the sail.

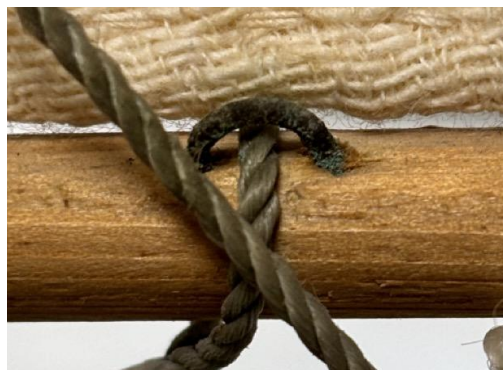
Figure 21. Blue-green corrosion product, hook near the stern of the boom.

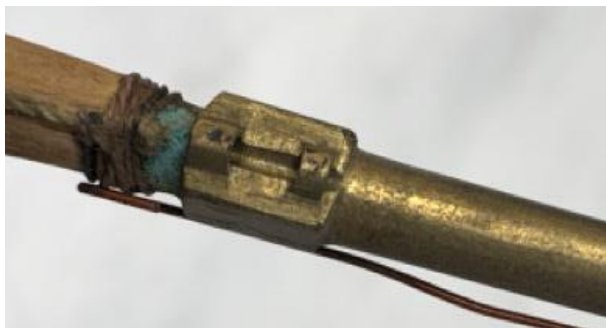
Figure 22. Blue-green corrosion product, top of the darting gun.

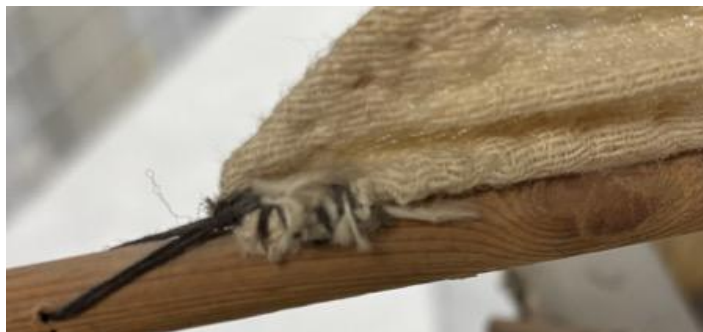
The sail is creased and sags at the lowest edge. There is minor and stable fraying at the corners of the sail (fig. 23). One rope attached to a bow thwart is in a disorganized pile in the hull.

Figure 23. Minor and stable fraying at the corners of the sail, likely originating from when this model was made.

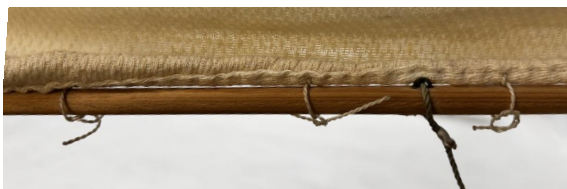
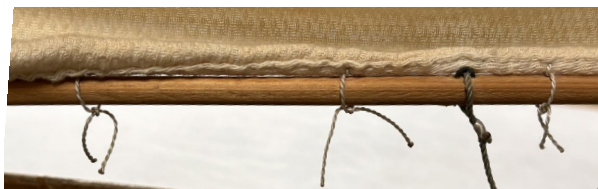
Figure 24. Three of six knots, before tightening threads.

Figure 25. Three of six knots, after tightening threads.

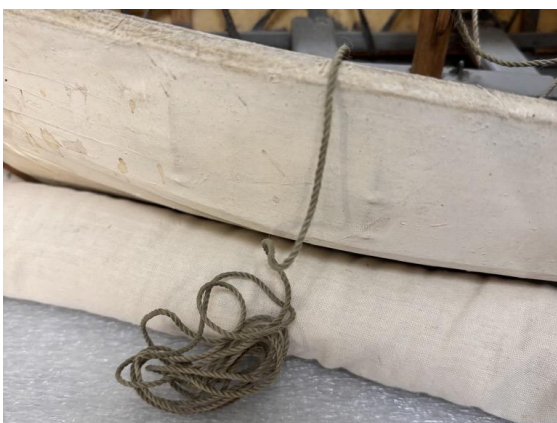
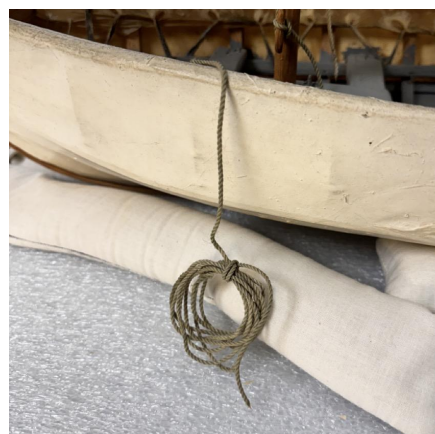
Figure 26. Bow thwart rope, before tying.

Figure 27. Bow thwart rope, after tying.

- Tied the rope attached to the bow thwart with the same knot technique as the other rope attached to the mast (figs. 26-27).

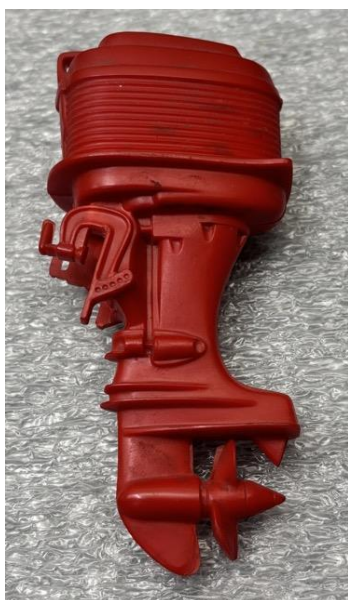
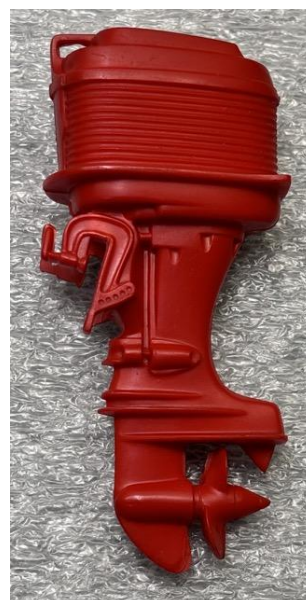
Figure 30. Before cleaning.

Figure 31. After cleaning.

- Reduced grime from the red motor accessory with swab-applied reverse osmosis water (figs 30-31).

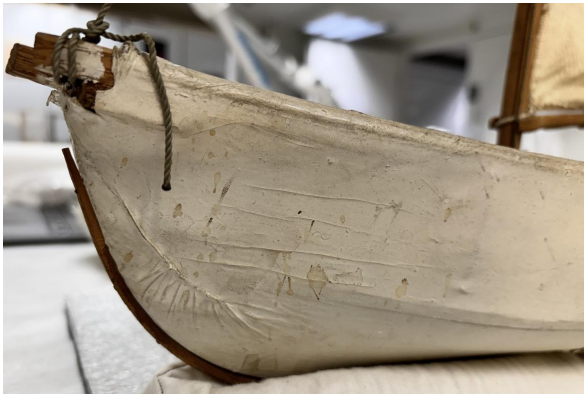
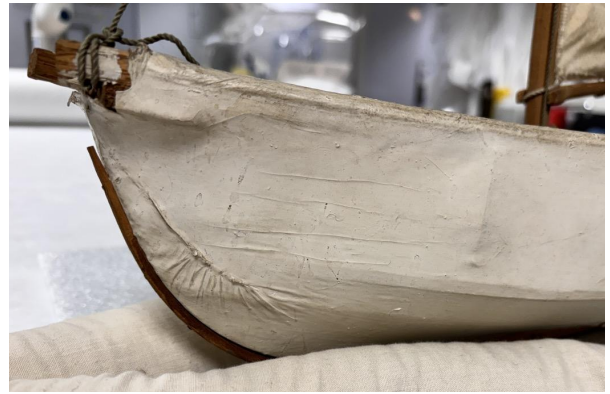
Figure 32. Before surface cleaning and stain reduction, hull exterior.

Figure 33. After surface cleaning and stain reduction with 0.5% Triton X-100 followed by isopropanol, hull exterior.

- Reduced brown stain on the hull exterior with swab-applied Triton X-100 (0.5%) in 10:1 reverse osmosis water and ethanol and cleared with reverse osmosis water, following testing (table 1, figs. 32-33). After this process, the surface chemistry was altered such that the stain could be effectively reduced further with swab-applied 1:1 reverse osmosis water and isopropanol.

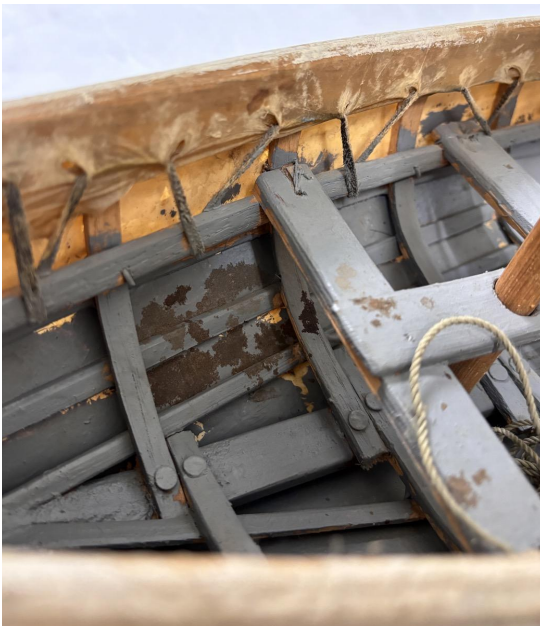
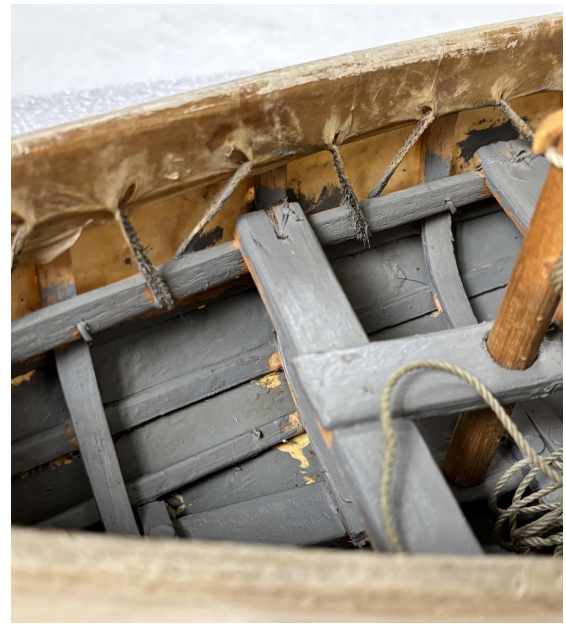
Figure 34. Before stain removal, interior frame and hull.

Figure 35. After stain removal, interior frame and hull.

- Reduced the brown stain on the inner painted frame and hull and thwarts with swab-applied deionized water (figs. 34-35).

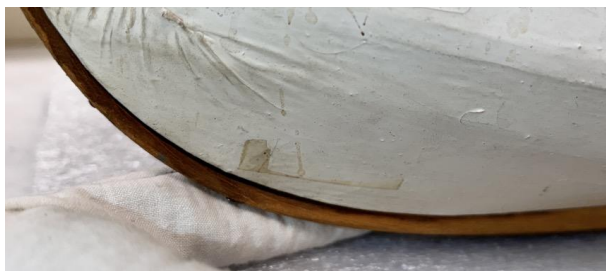
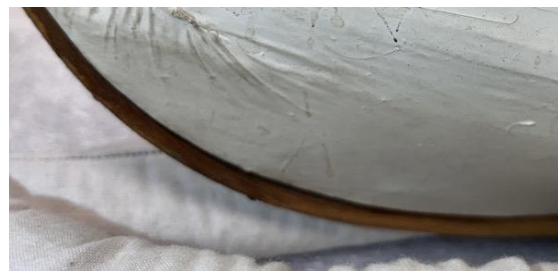
Figure 36. Before tape removal.

Figure 37. After tape removal.

5. **Removed pressure sensitive tape and residue from the bow hull exterior with a heated spatula, tweezers, and a spatula (fig. 36-37) (est. 0.25 hours).**

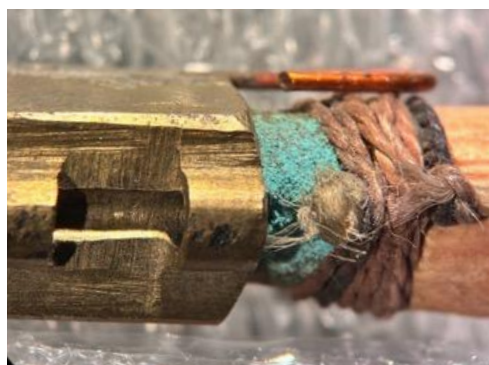
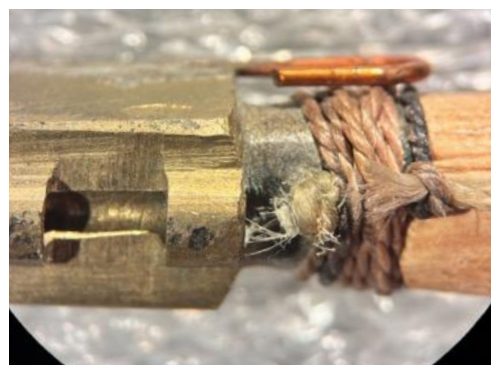
Figure 38. Before corrosion reduction, darting gun. 10x magnification.

Figure 39. After corrosion reduction, darting gun. 10x magnification.

6. **Reduced corrosion products with an insect pin, porcupine quill, and microswab-applied mineral spirits from the darting gun, ice space, and seal float as well as the metal components joining the sail on the mast and boom (figs. 38-39). Removed loose corrosion products from the surrounding cord with a low-speed HEPA-filtered vacuum. Stabilized metal with a 3% Paraloid B-48N coating (est. 3 hours).**

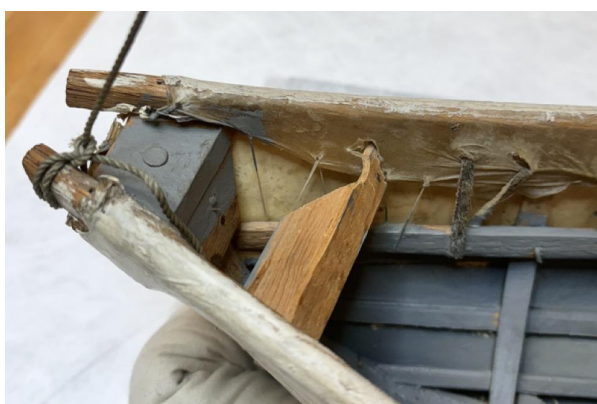
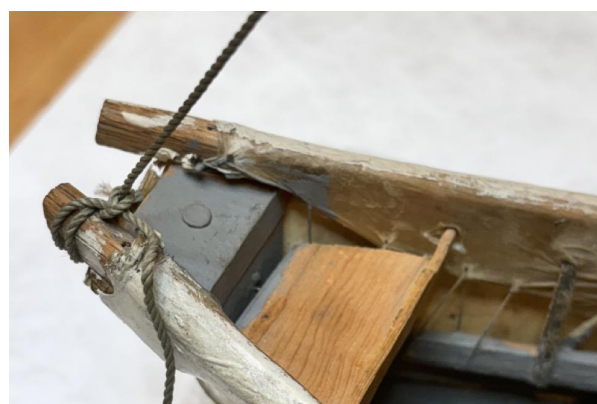
Figure 40. Before stabilizing the bow shelf.

Figure 41. After stabilizing the bow shelf.

7. **Re-secured the bow shelf with 15% Paraloid B-72 in 1:1 acetone and ethanol brush-applied to the pin (figs. 40-41). Pressure was maintained with finger pressure for 5 minutes (0.25 hours).**

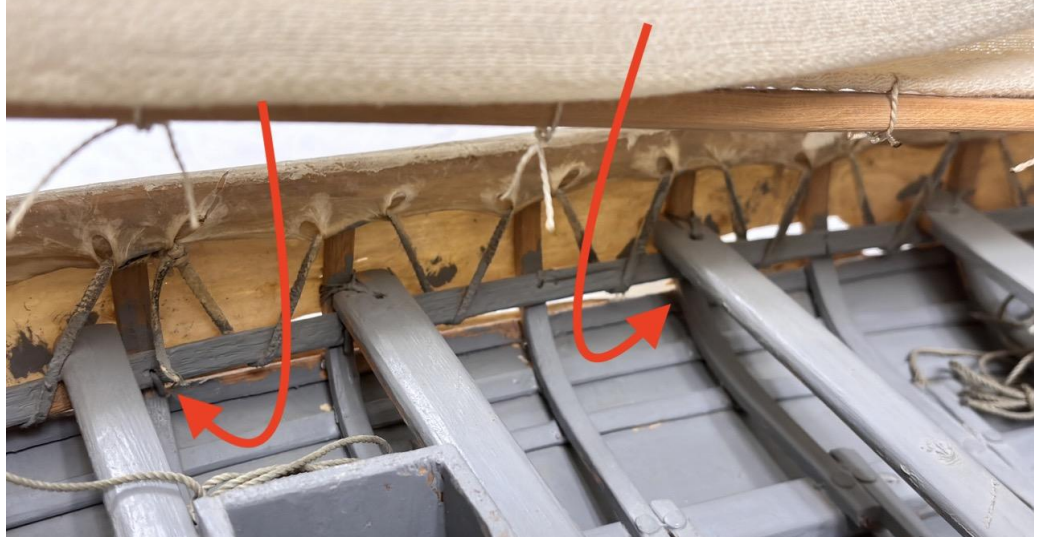
Figure 42. Fill locations between the outermost side stringer and the side ribs on the PL side.

8. **Stabilized the gaps that occurred when the wooden outer stringer separated from the side rib on the PL side of the hull (fig. 42) with a fill that bridges the gap (1.5 hours).**

- A barrier layer of 15% Paraloid B-72 in 1:1 acetone and ethanol was applied with a brush. The fill was composed of BEVA gel bulked with cellulose fibers until the material formed a putty. It was applied with

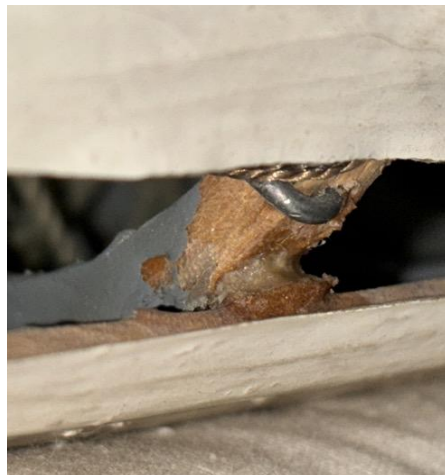
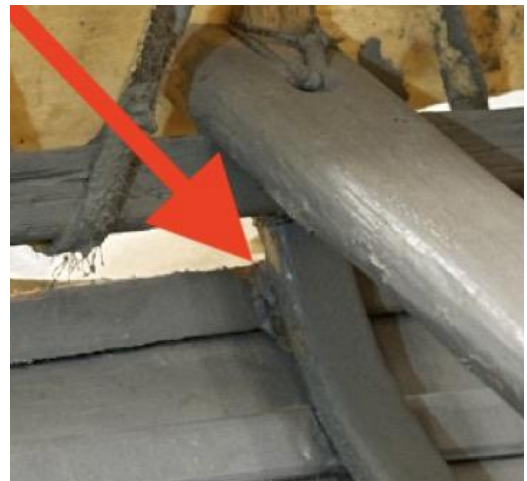
Figure 43. After smoothing.

Figure 44. After inpainting.

a spatula and shaped with isopropanol and a porcupine quill (fig. 43). Inpainted with Golden Artist Acrylics (fig. 44)
