# Winterthur/University of Delaware Program in Art Conservation

## Conservation Examination Report and Treatment Proposal

**Owner:** Winterthur Museum, Garden & Library  
**Accession #:** 1965.2058  
**Object:** Clay Pipe  
**Artist/Maker:** Zenith Plateelbakkerij en Pijpenfabriek (Zenith Delftware Pottery and Pipe Factory)  
**Object Date:** 1934-1955  
**Materials:** Earthenware  
**Dimensions:** 16 ¾ x 1 ⅛ x 3 ¼ in. (l x w x h)

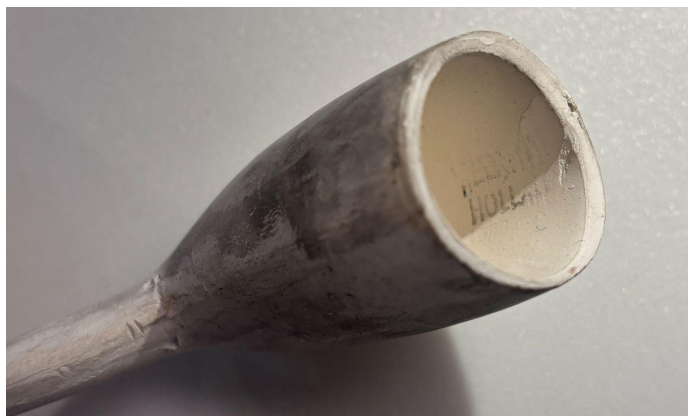
Figure 1. Manufacturer stamp, bowl interior.<sup>2</sup>

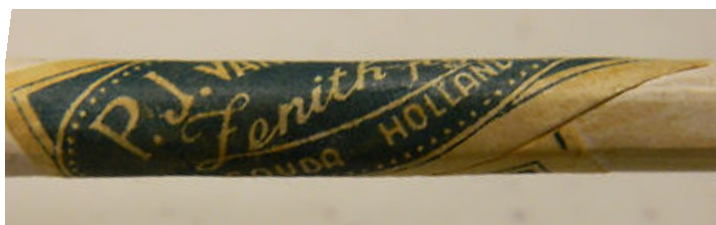
Figure 3. Paper band on a similar pipe showing the label “P.J. Van der Want, Zenith, Gouda, Holland (Worthpoint Antiques company, 2024).

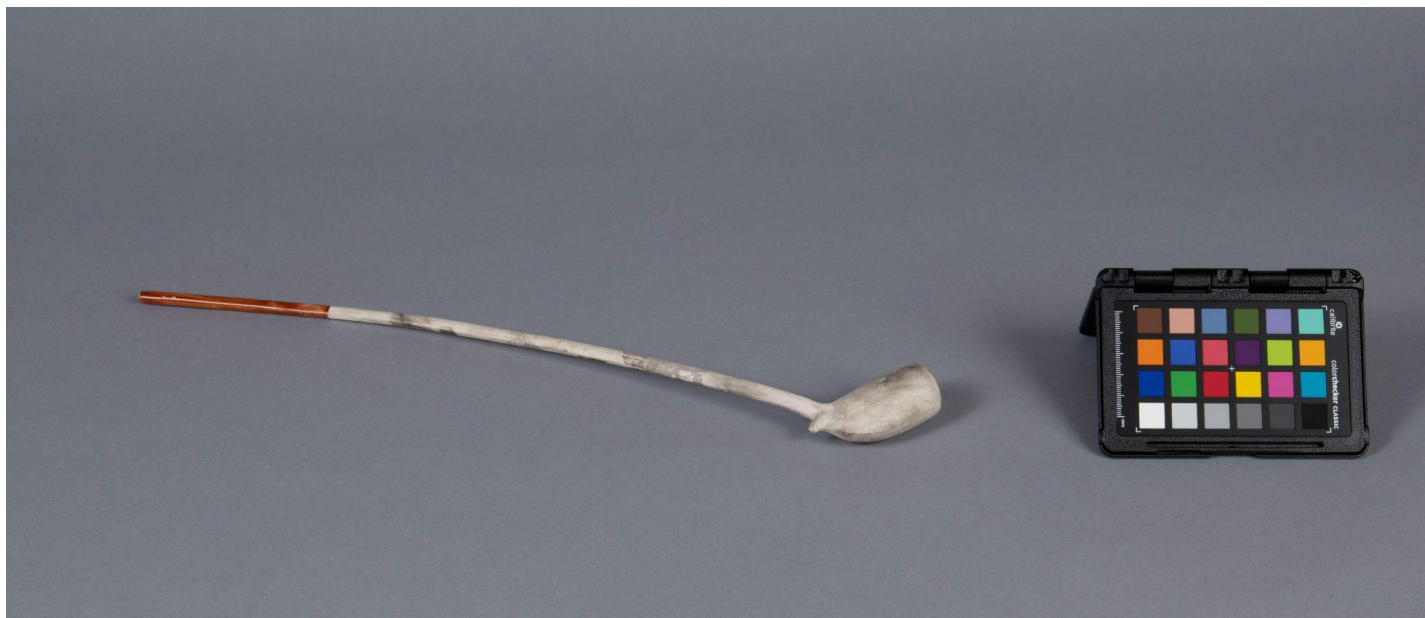
Figure 6. Overall after treatment, normal illumination.<sup>4</sup>

The two components of the pipe were rejoined with epoxy. Remaining gaps were filled and aesthetic legibility was reestablished with inpainting. Red stains were reduced.

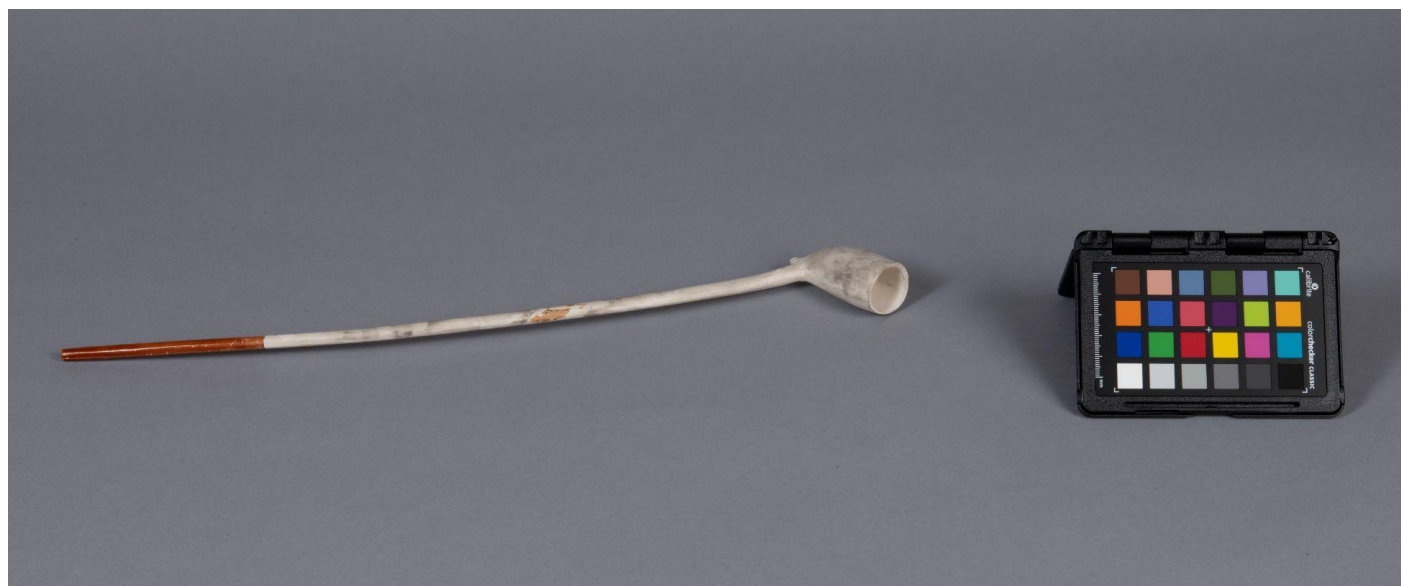
Figure 7. Overall after treatment, normal illumination.

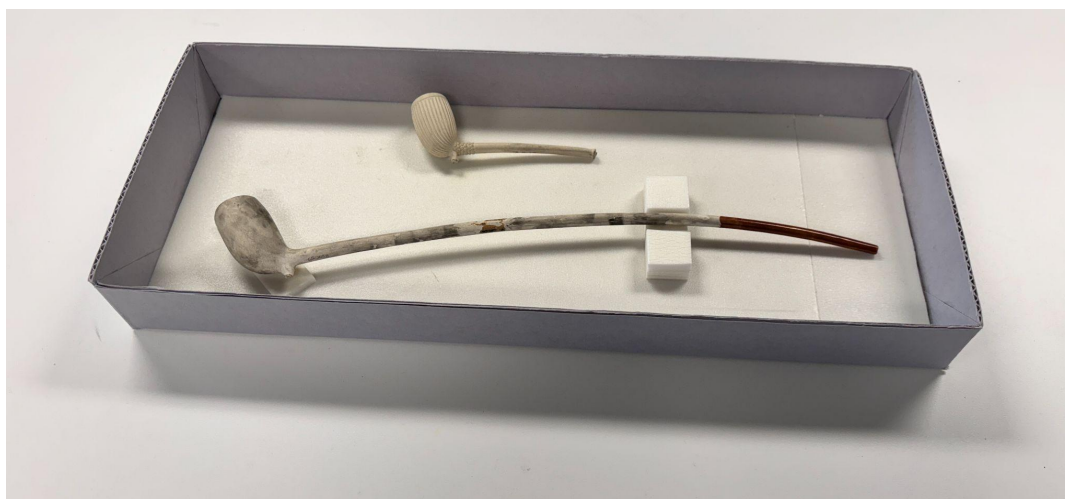
Figure 13. New housing enclosure which can fit additional pipes, as requested by Leslie Grigsby.

8. The secondary pencil accession number applied near the stem was removed and the accession number near the bowl was left intact. The second pencil accession number was reduced with a carved Mars STAEDTLER eraser in deionized (DI) water. Eraser crumbs were removed with a hake brush. The base of the bowl is the standard place for accession labeling of pipes in the Winterthur collection, as established in consultation with Sarah Johnson, Assistant Registrar at Winterthur Museum, Garden & Library (*30 minutes*).
9. Updated an existing blueboard housing enclosure for long-term storage with Volara supports (fig. 13) (*15 minutes*).
