# Winterthur/University of Delaware Program in Art Conservation

## Conservation Examination Report and Treatment Proposal

**Owner:** Winterthur Museum, Garden & Library  
**Accession #:** 2003.0057  
**Object:** Surveying Compass

**Proposal Date:** November 11th, 2024

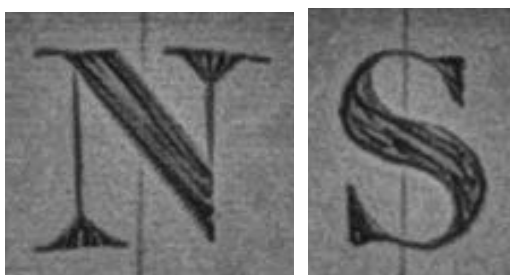
- **X-radiography:** with the assistance of Lauren Fair, I conducted X-radiography to investigate the manufacturing methods of the compass. While the interior mechanisms could not be elucidated further with our equipment, we could see that there are incised marks underneath the black inlays on the dial numerals. Refer to “Appendix IV. X-Radiography” for full images and additional information.

Figure 16. Incised metal of compass dial lettering. Crop of X-radiograph without filter.

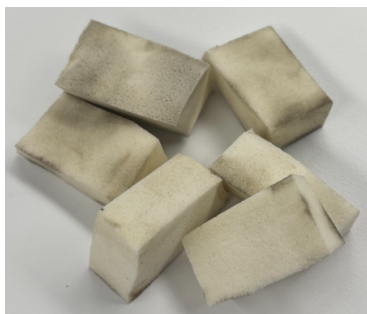
Figure 18. Soiled cosmetic sponges, after cleaning.

- First, I overall surface cleaned the compass enclosure, compass dial, cover glass, and cover glass border with a low-speed HEPA-filtered vacuum and cosmetic sponges (fig. 18).

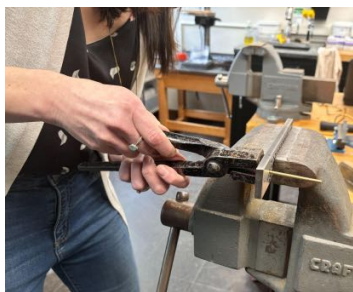
Figure 23. Lauren Fair drawing the brass to the correct gauge.

- **Slotted screw type A, north end:** I created a replacement screw with the guidance of Kate Jennings, Metals Subject Leader in the Conservation Studies Program at West Dean College, and Lauren Fair. 18-gauge brass rod was thinned slightly by periodically annealing and drawing the rod through #1 on ART 110 draw plate for the screw body (fig. 23). I threaded the screw with a 6-32 die (fig. 24). To create the head, I cut larger gauge brass to length to match the head of other screws, and then I matched the slot with a hack saw of similar kerf width as the original screw slot width (figs. 25-26). To finish the screw, I soldered the head onto the body with silver brazing solder and flux (fig. 27). Finally, I polished the new screw with Solvol Autosol<sup>15</sup> and steel wool #0000, clearing polishing residues with ethanol (fig. 28). I completed inpainting to the visible screw head with Gamblin Conservation Colors<sup>16</sup> solubilized with 80% isopropanol with 20% petroleum benzene. A final layer of inpainting was completed with a wash of golden fluid acrylics<sup>17</sup> before fitting the screw to the north instrument attachment arm (figs. 29-30).

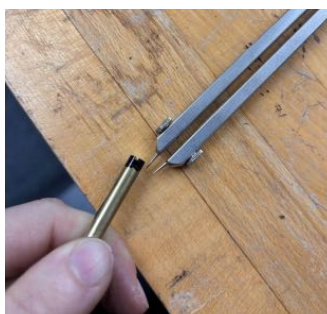
Figure 26. Marking the height for the replacement screw head, cut with a jeweler saw.

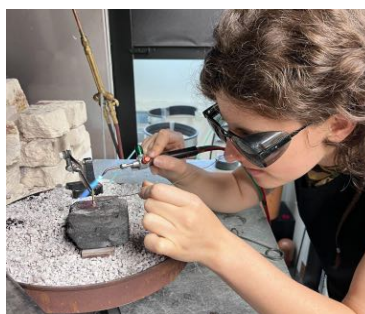
Figure 27. Soldering the replacement screw components together with an oxyacetylene torch.

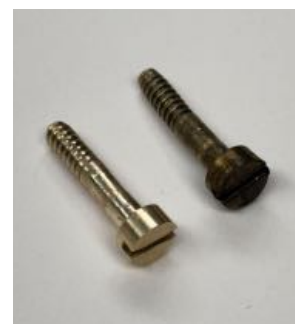
Figure 28. Matched dimensions of the replacement screw.

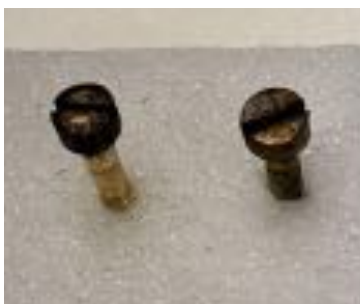
Figure 29. Inpainting to match the original screw.

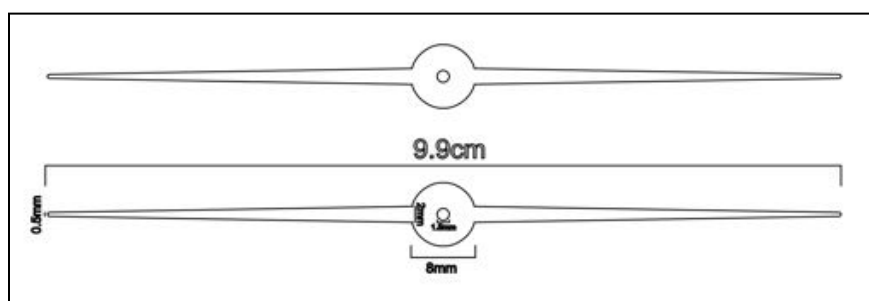
Figure 31. Needle digital rendering. Image courtesy Mia Kaplan.

- **Needle:**<sup>18</sup> Mia Kaplan, metalsmith at Night Shift Studio, fabricated a replacement compass needle based on a design that was approved by Ann Wagner. Refer to “Appendix V: Needle Replacement” for a discussion of what this design and construction should entail. The needle was laser cut from 1008 mild steel<sup>19</sup> based on a digital rendering. The cap of the needle was made from 5/16” diameter Ultra-Machinable 360 brass rod.<sup>20</sup> This cap also incorporated a small sapphire set into the underside; the sapphire was provided by Brittany Cox at Memoria Technica. Mia fabricated the needle from these materials (figs. 31-36). I joined the needle to the needle cap with Epo-Tek® 301-2 epoxy resin.<sup>21</sup> When placed on the pivot, the needle spins freely. However, if tilted, the needle can become slightly askew. I coated the needle with Cosmoloid H-80 microcrystalline wax<sup>22</sup> in Shellsol D-38, buffed slightly. To hold the needle in place long-term, I rolled a small piece of Parafilm M<sup>23</sup> to wrap around the base of the pivot. The needle does not move freely in this arrangement. The needle was not magnetized, but this can be pursued at a later date. Additionally, no “north” marker was pursued at this time, but this can also be added at a later date if desired.

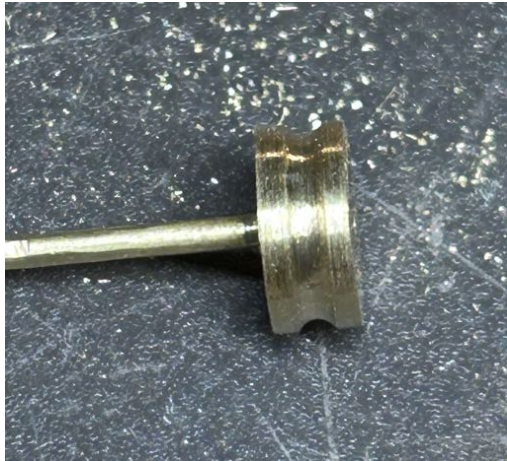
Figure 33. Lathe-turned needle cap. Image courtesy Mia Kaplan.

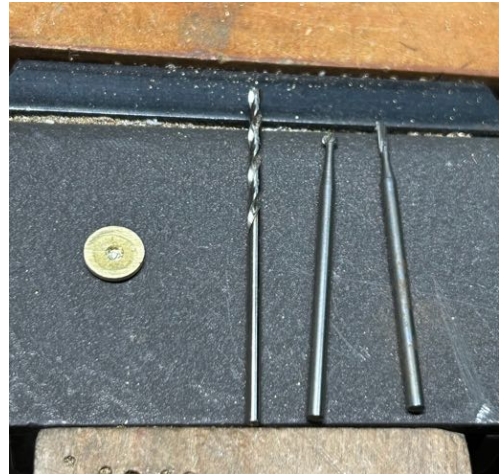
Figure 34. Needle cap, underside hole for jewel bearing. Mia created the hole with the three tools pictured: a drill bit, ball bur, and baby end mill. Image courtesy Mia Kaplan.

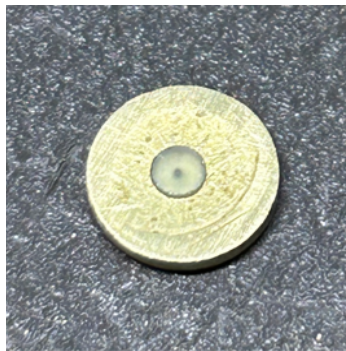
Figure 35. Sapphire flush with the underside of the needle cap. The hole in the center marks the surface where the pivot comes into contact with the needle. The sapphire was provided by Brittany Cox. Image courtesy Mia Kaplan.

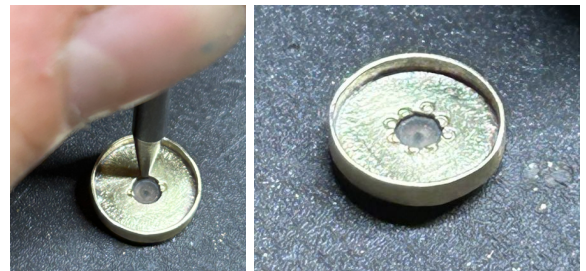
Figure 36. Bead-set sapphire (left image: process; right image: complete), with lip to create a pressure-fit reversible lid attachment between this component and the lathe-turned needle cap. Image courtesy Mia Kaplan.

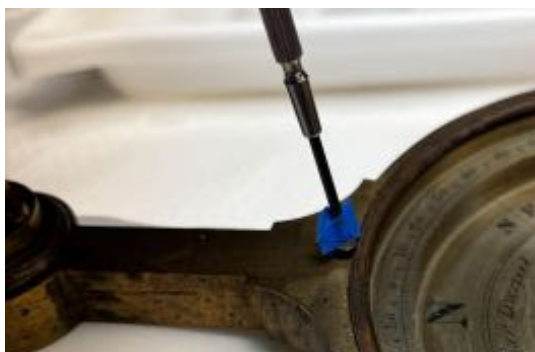
Figure 38. Screwdriver with tape for abrasion protection.

- I returned the glass to the raised shelf and secured it in place with the cover glass border and two screws. The border was returned to the object with a slightly different orientation to minimize stress on warped areas. I covered a screwdriver with tape to minimize the risk of any surface marks (fig. 38).

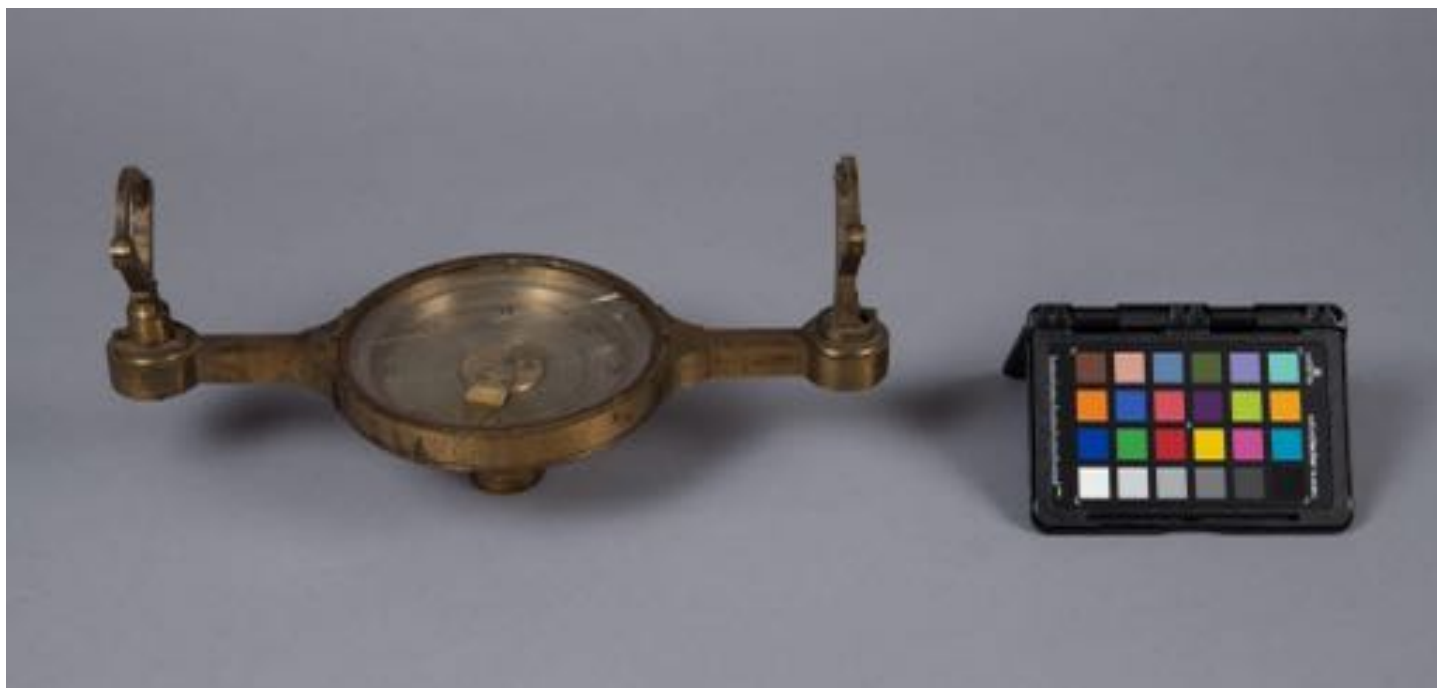
This surveying compass is stable and in fair structural and aesthetic condition with a loose component, assorted variegated corrosion products, and a missing compass needle.

The cover glass is split in two components with a 10.5 cm fracture structurally held in place by the cover glass ring. This is consistent with damage that may have occurred during the objects lifetime. There is a 1 cm surface abrasion on the glass on the eastern side. There is no change in condition report on EMu for this object. Otherwise, the glass is in good aesthetic condition. The metal cover glass border is slightly deformed along the eastern edge.

Figure I-1. Before treatment, side view.<sup>26</sup>

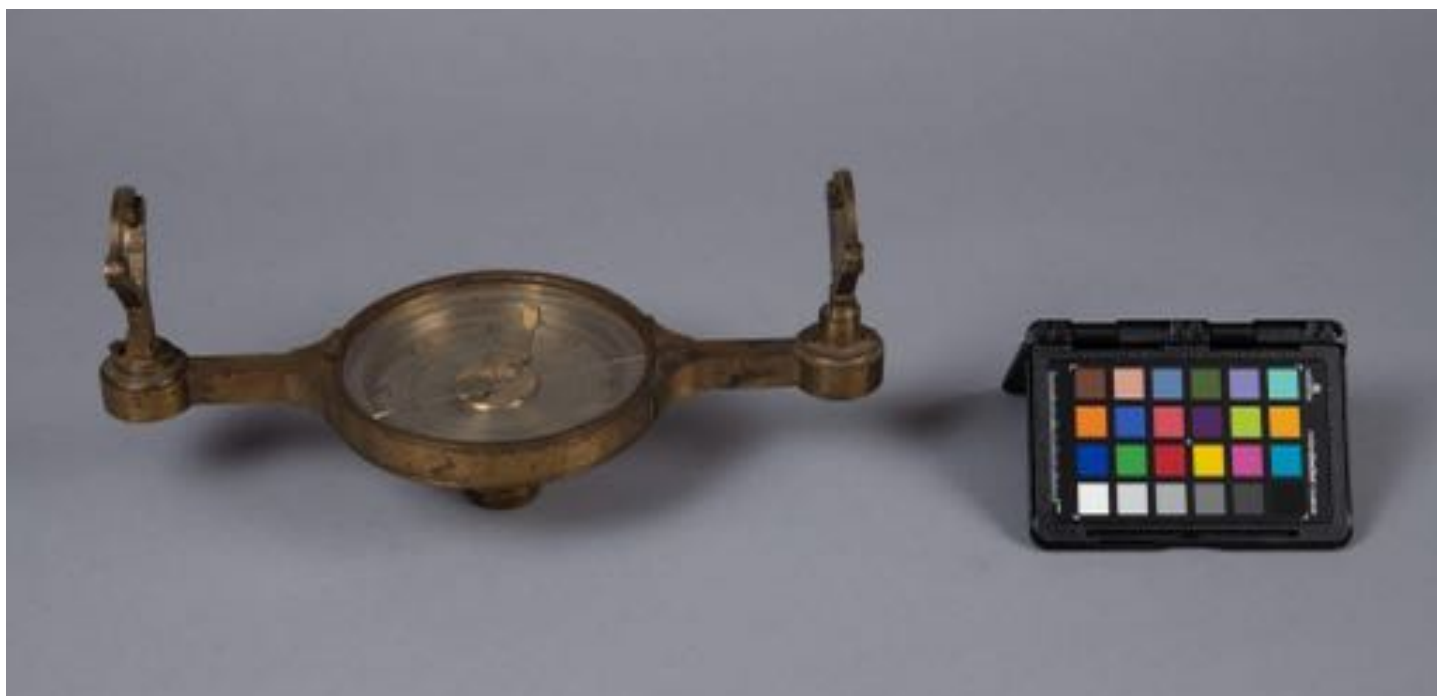
Figure I-2. Before treatment, side view.

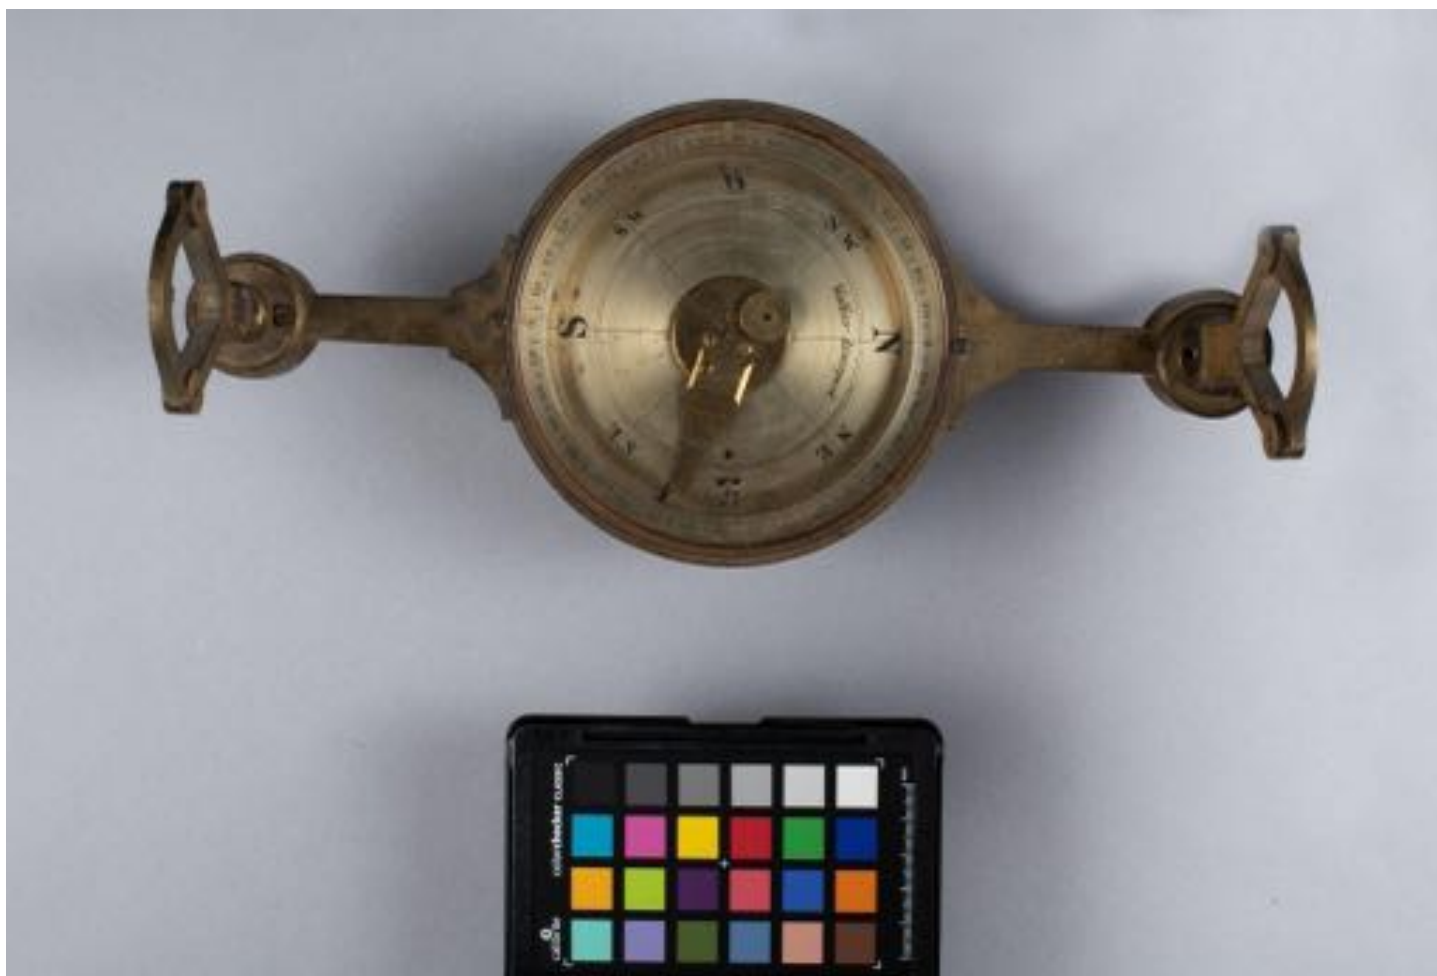
Under the cover glass and across the compass dial, there is loose soiling and evidence of insect activity. A winged insect is trapped under the cover glass border near the west side, and dead insects are present near corrosion and soiling on the compass dial near the east side. The black infill within engraved areas has some alligatoring and losses, particularly the center of “E” (fig. 10). The black material in the engraved text may be structurally unstable, but further examination is not possible prior to removal of the cover glass. The coating applied to the dial has some crazing and flaking, particularly in areas of thicker application on the raised chapter ring (fig. 11). The coating is highly brittle and has minor losses primarily visible under magnification. It may also be contributing to the slight yellow haze on the surface of the dial.

Figure I-3. Before treatment, overall top.

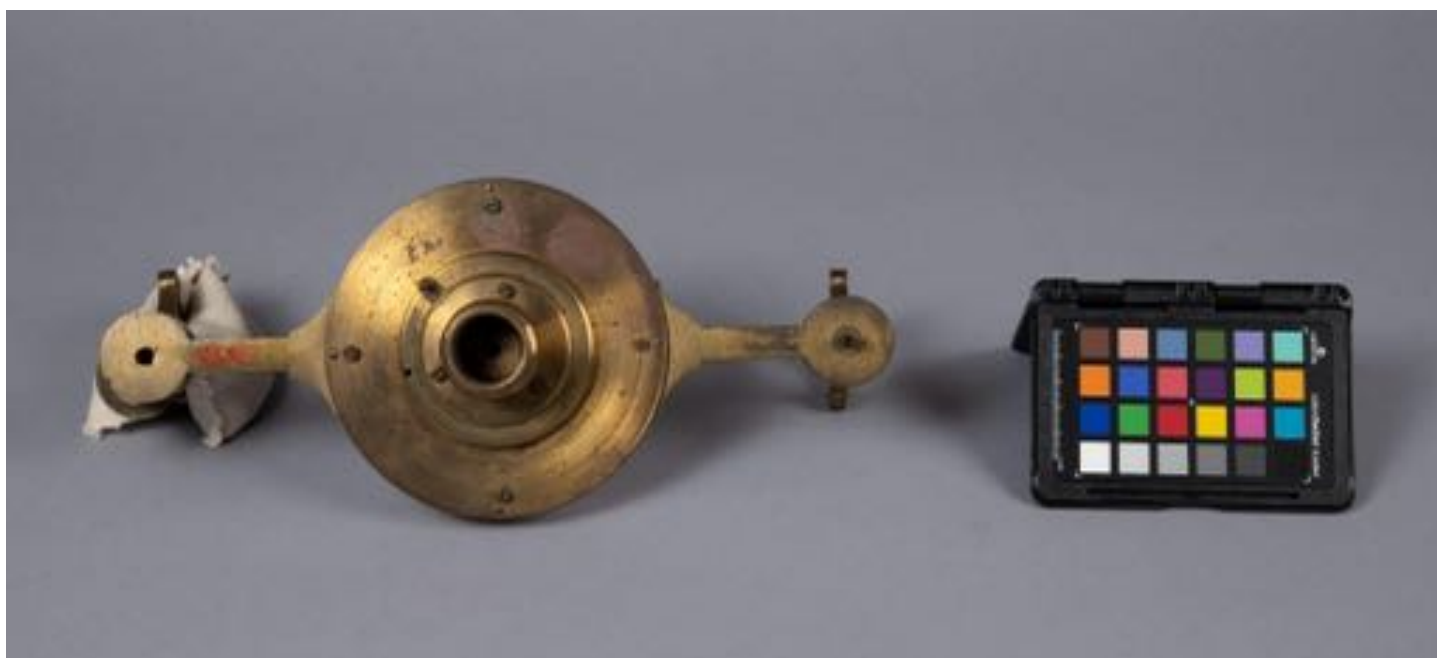
The northern instrument holder and base are missing one screw (type A), which contributes to its unintentional ability to swivel on the attachment arm. The one intact screw is slightly raised and does not create sufficient structural support to hold the components in line with friction and pressure.

Figure I-4. Before treatment, overall bottom.

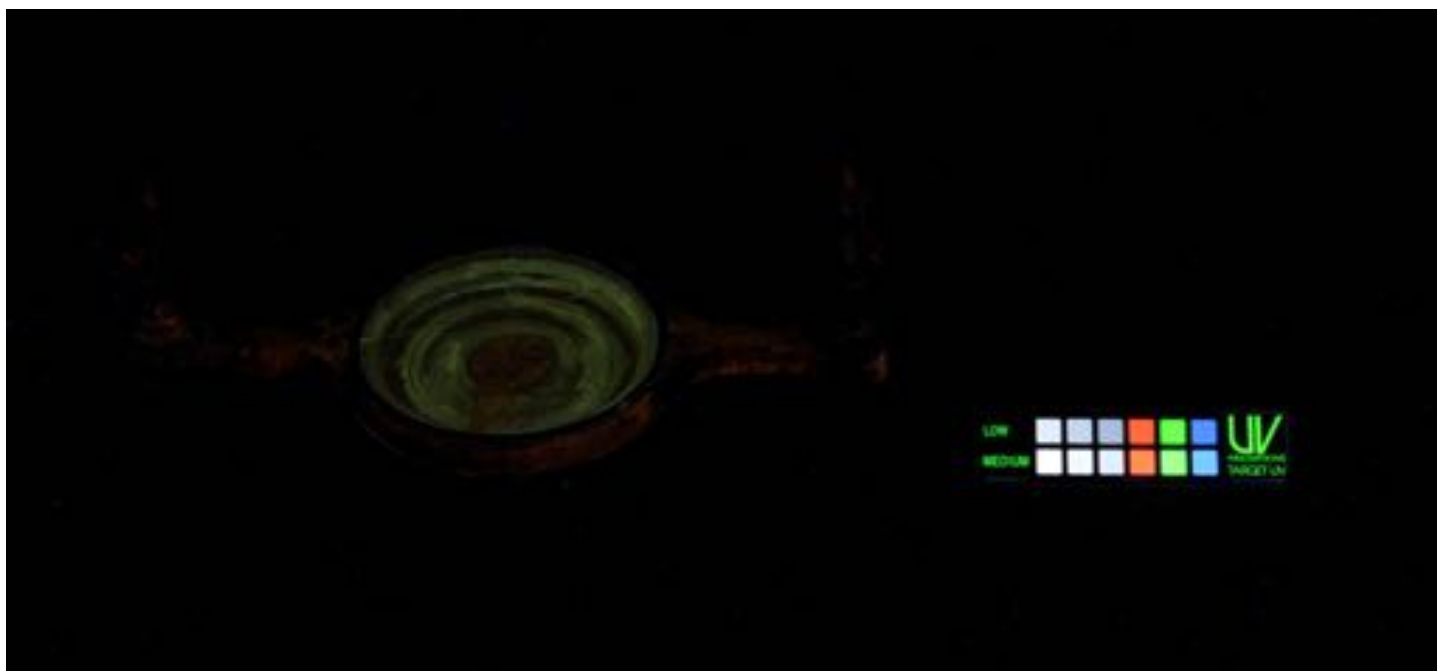
UV examination revealed information on the coatings and materials (fig. 12) (see “Appendix I: Before Treatment Photography” for overall UV images). Under long wave UV (UVA) examination, there are two characteristic fluorescences: the compass dial fluoresces yellow-green and everywhere else is bright orange. This indicates that the compass dial has a different coating than the rest of the compass. Yellow-green is often consistent with a natural resin, and orange is often consistent with shellac. Additionally, there is apparent streakiness in both coatings under UVA, and the corrosion observed is consistent with misses during application or abrasion to the coating. Under ultraviolet short wave (UVB) examination, the surveying compass absorbs all radiation, except for the glass which appears a uniform cloudy yellow (see “Appendix I: Before Treatment Photography” for additional information). The yellowish cast may be related to iron or manganese in the glass, but this is not conclusive; what is conclusive is that the glass is non-lead containing as it would otherwise fluoresce bright blue under UVB (Lauren Fair, personal communication, November 12th, 2024). The incised letters and lines fluoresce bright white due to the binder or a coating.

Figure I-5. Before treatment, side view, UVA (long-wave).<sup>27</sup>

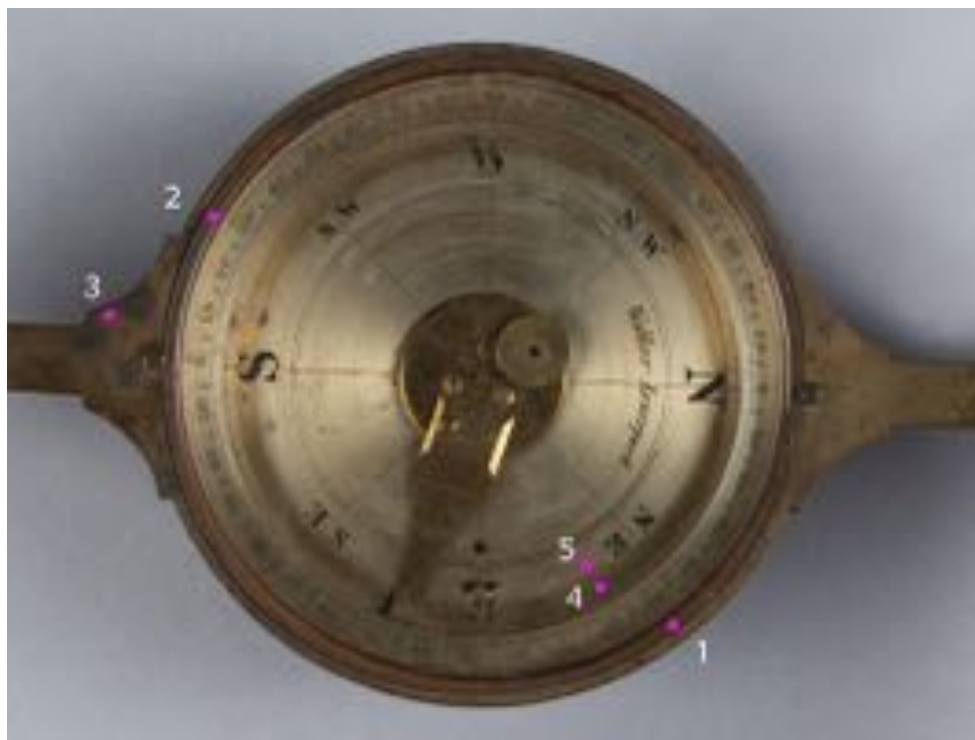
Figure III-1. Analysis locations (cover glass removed for  $\mu$ -XRF).

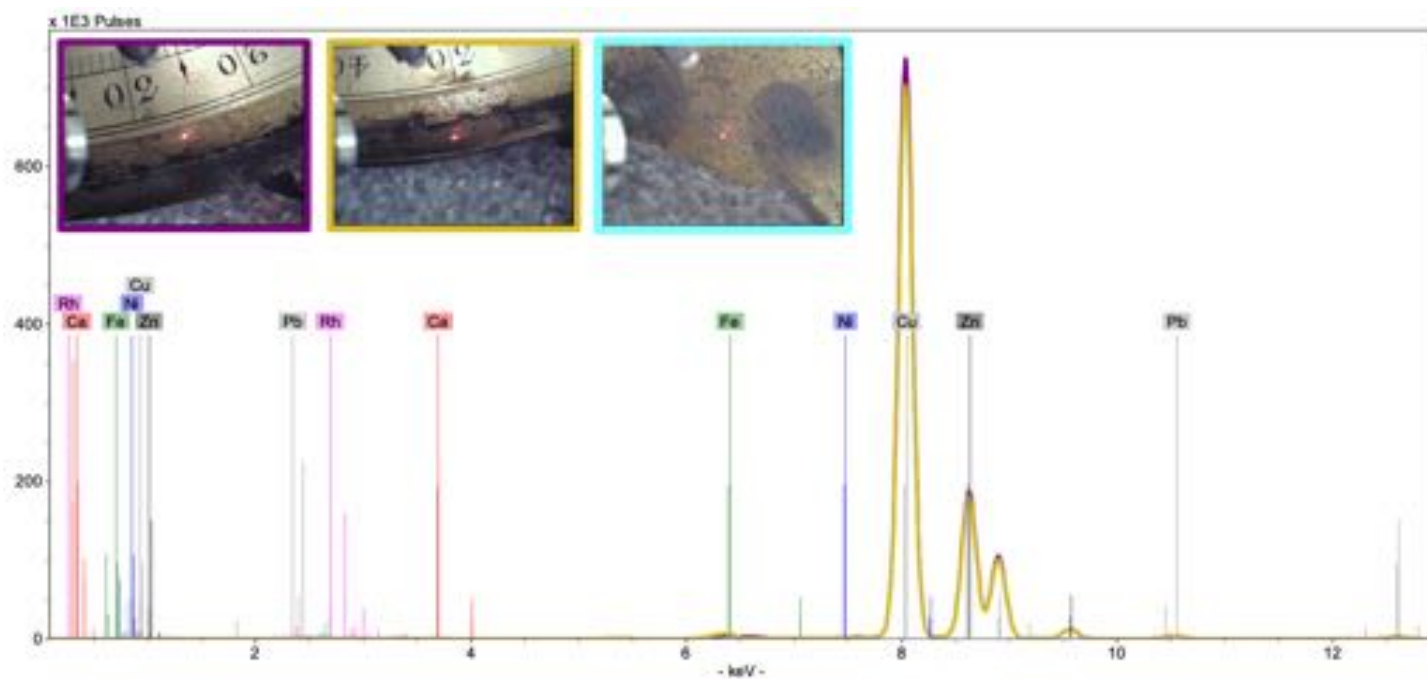
Figure III-2. XRF spectrum of the lower rim (purple, location 1), upper rim (dark yellow, location 2), and enclosure (cyan, location 3).

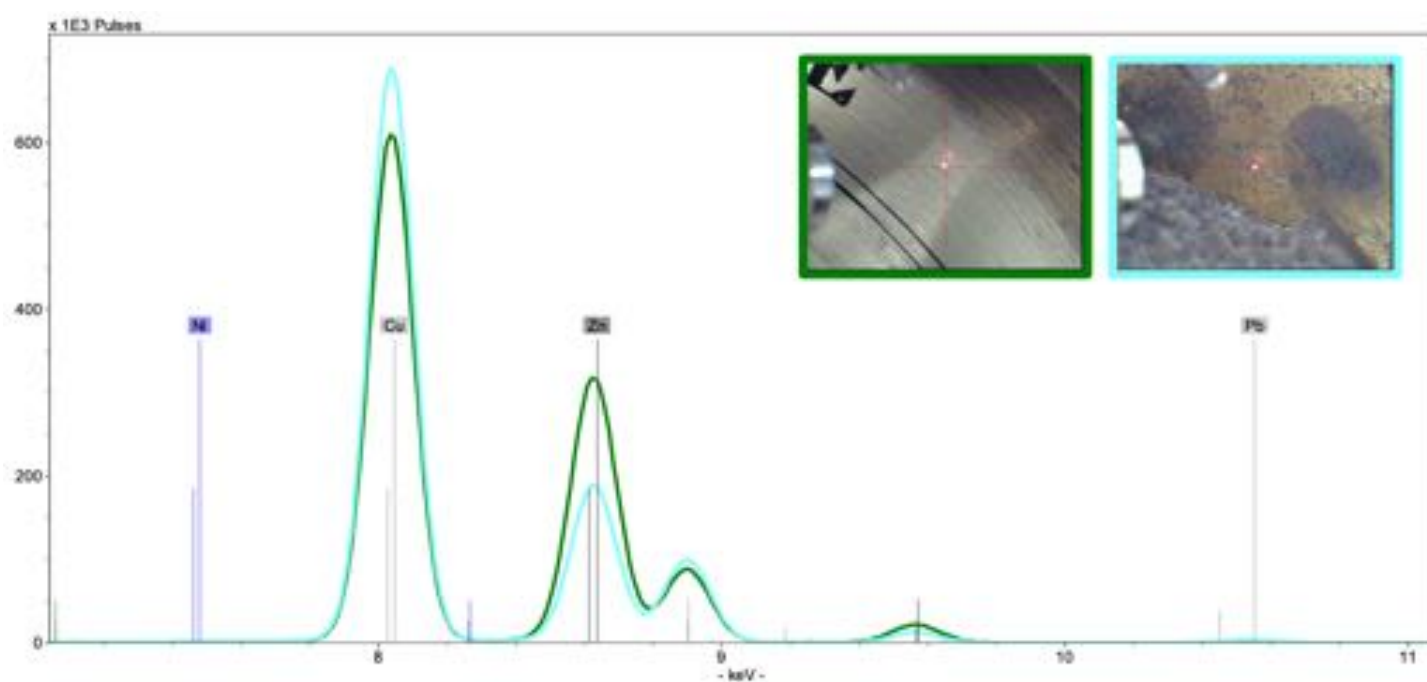
Figure III-3. Select region of the XRF spectrum of the dial (green, location 5) and enclosure (cyan, location 3).

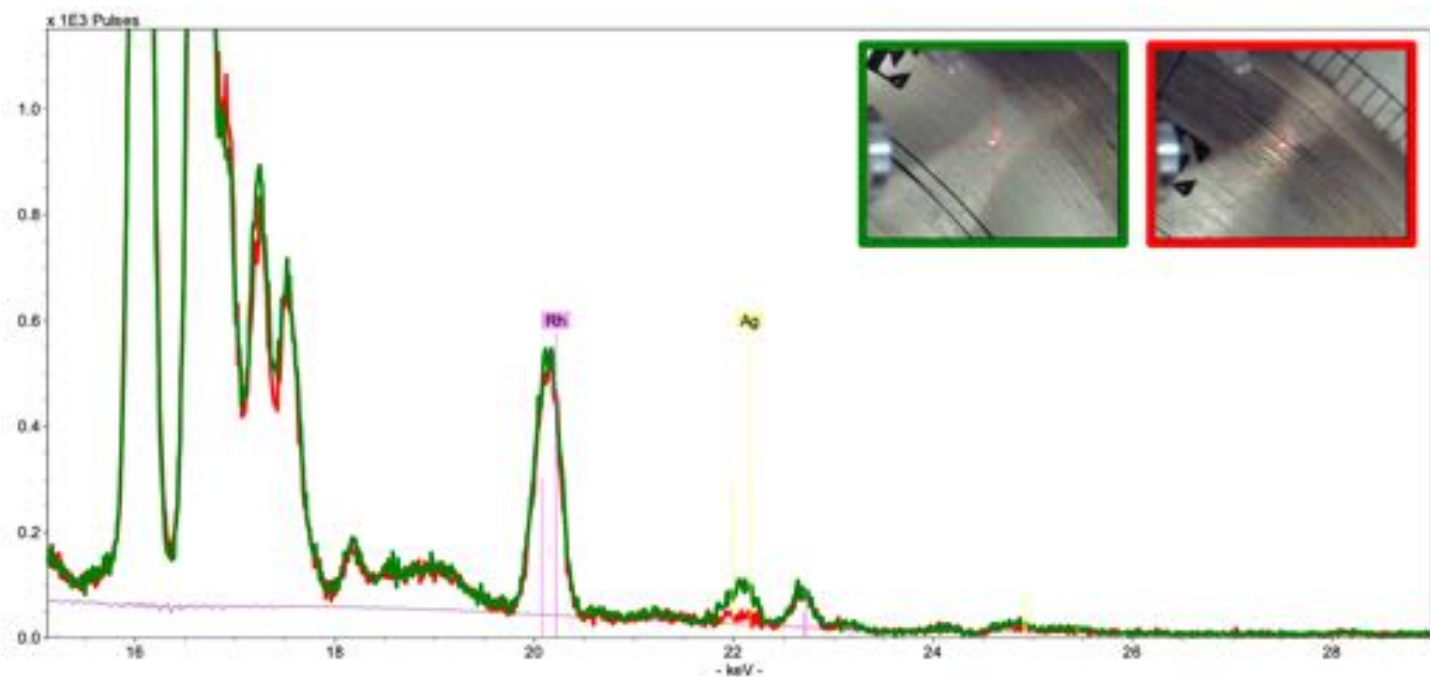
Figure III-4. Select region of the XRF spectrum of the non-abraded region of the dial (green, location 5) and the abraded region (red, location 4).

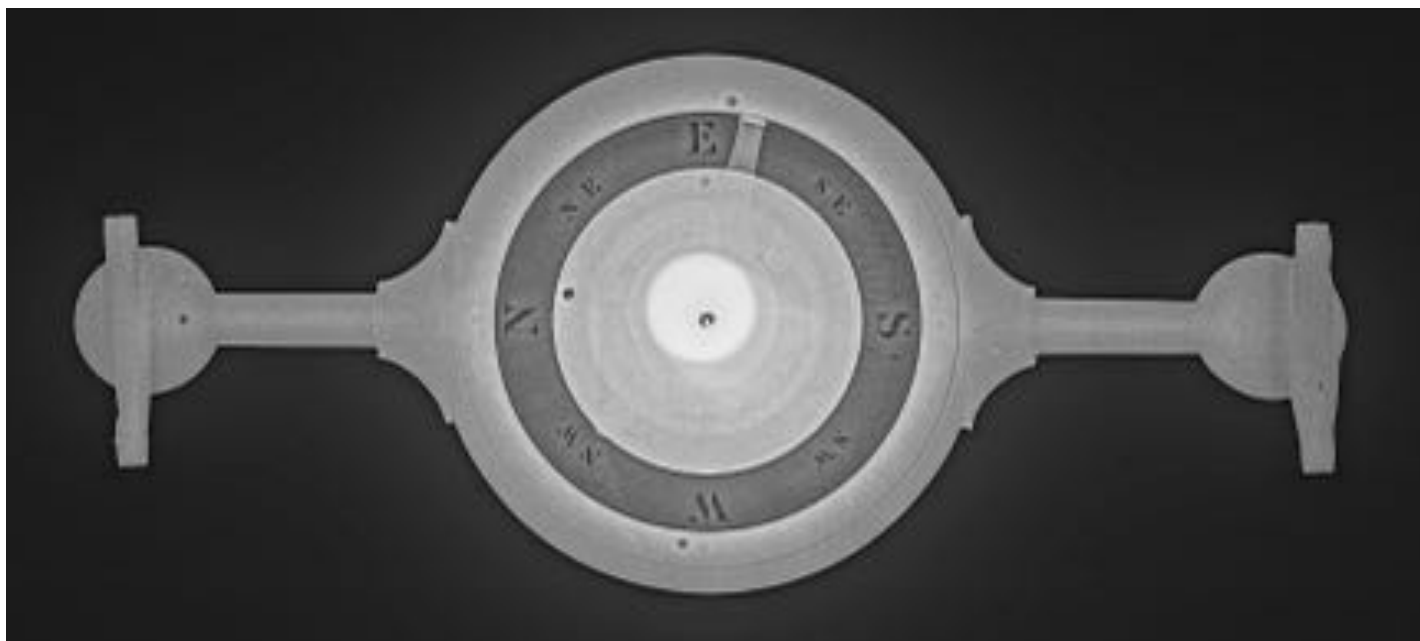
Figure IV-1. X-radiograph. Image captured in collaboration with Lauren Fair, March 2025.

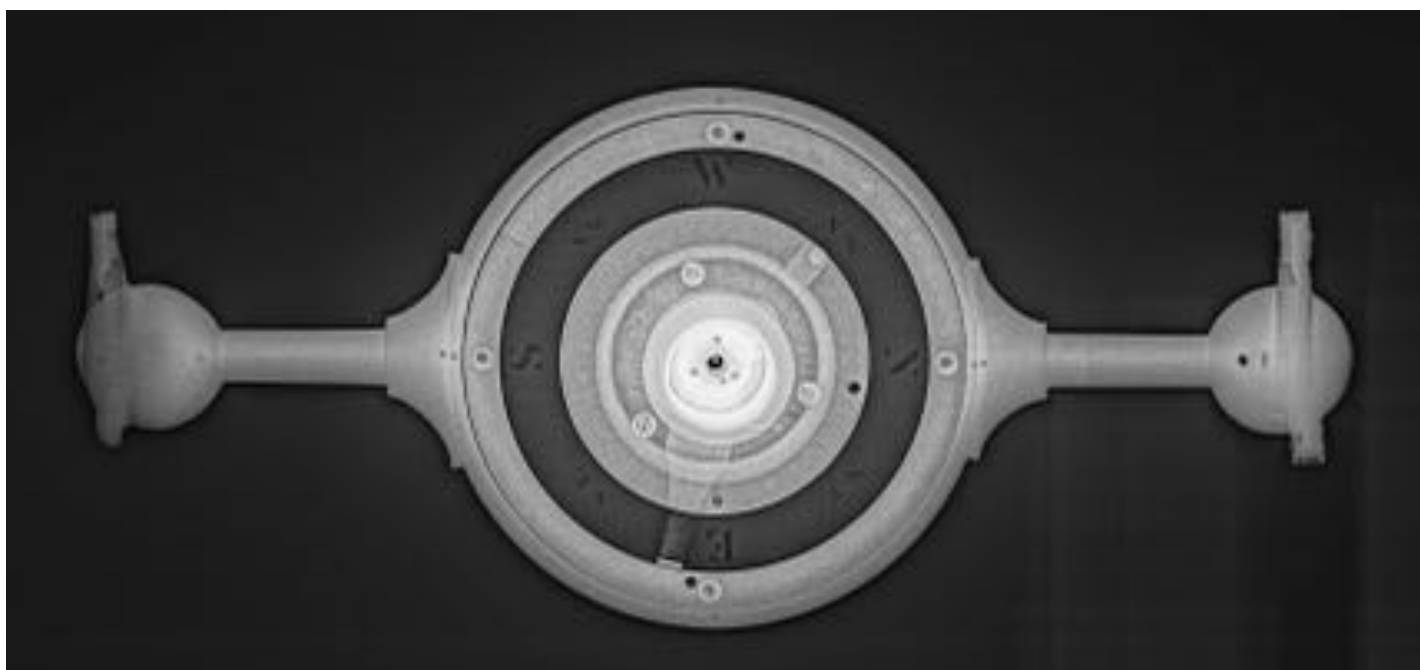
Figure IV-2. X-radiograph with GE Rhythm Review Flash! filter. Image captured in collaboration with Lauren Fair, March 2025.
