# ANCHORAGE MUSEUM

## Conservation Examination Report and Treatment Proposal

**Accession #:** 1988.13.1

**Object:** Model, Umiak with Sail

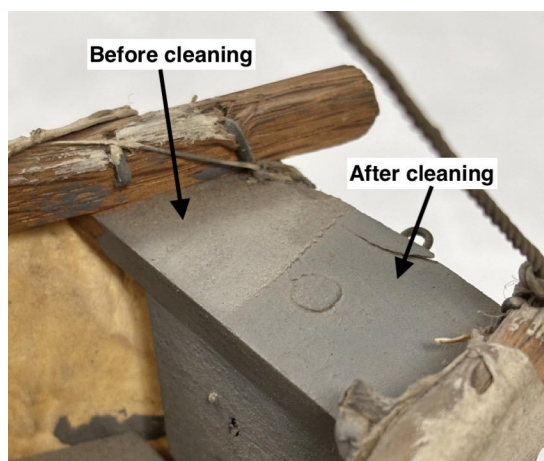
Figure 28. Surface cleaning the backboard.

3. **Conducted cleaning of the umiak and model accessories (2.5 hours).**
  - Dry surface cleaned with a soft-brush and low-speed, HEPA-filtered. Reduced embedded dirt and dust with cosmetic and soot sponges (figs. 28-29).

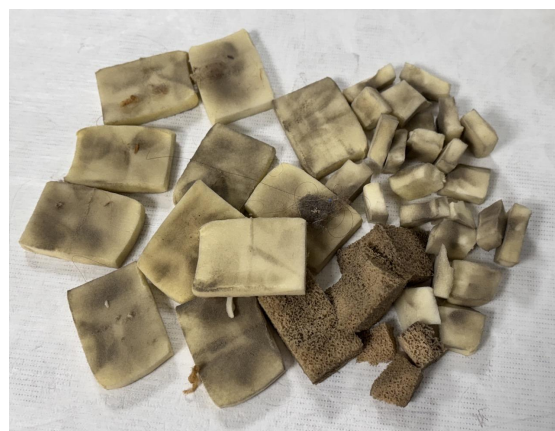
Figure 29. Sponges after the first pass of dry

cleaning.

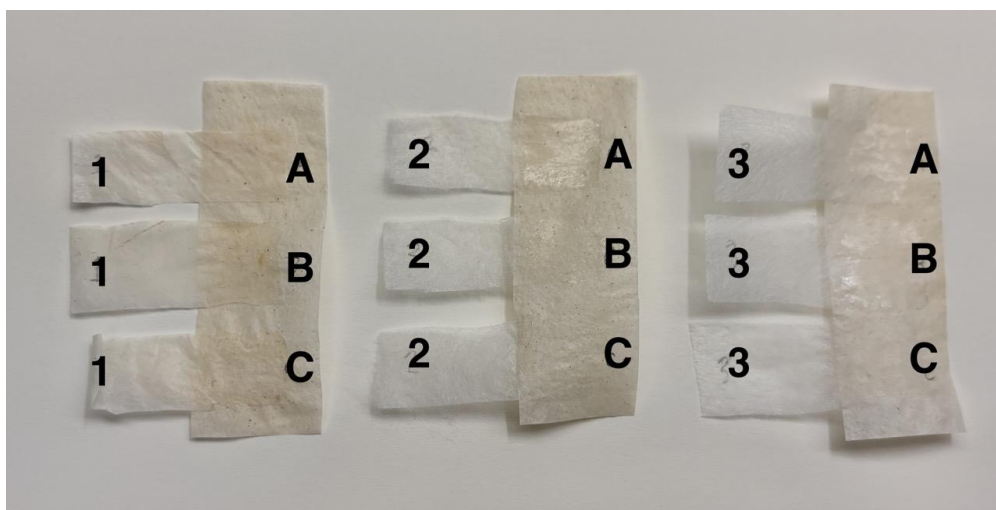
- **Heat tested the painted hull to evaluate the potential use of heat-activated BEVA 371 film:** a heated spatula held in place for 8 seconds on a low setting over a silicone-release paper on the hull caused no notable damage, actually gently relaxing the hull and allowing for slight re-establishment of planarity.
- **Mock-ups:** Tested three backing materials and three adhesives on 1-ply alum taxed goldbeaters skin to mimic the marine mammal organ painted hull (fig. 44, table 2). One final mock-up was completed with BEVA 371 film, the most promising option, to adhere goldbeaters skin 2-ply transparent, tengucho (thick), and sekishu (medium) to 1-ply alum taxed goldbeaters skin. The two-ply goldbeaters skin buckled less and had a nearly invisible appearance while maintaining sufficient strength. The thicker tengucho did not have any issues with gloss.

Figure 44. Mock ups. Materials tested: 1-ply alum tawed goldbeaters skin (1), 5 gsm sekishu thin (2), Tengucho mm (3). Adhesives tested: BEVA 371 Film (A), 3:1 Lascaux 498 and Lascaux 303 (B), thick wheat starch paste (C).

- **Results:** BEVA 371 film was selected as the adhesive material. 2-ply goldbeaters skin was selected for smaller fills, and tengucho medium was selected for the large gap on the PL side of the hull.

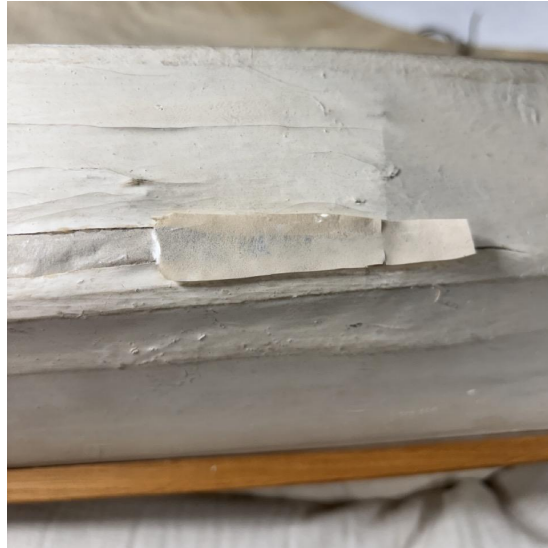
Figure 45. Toned paper with BEVA 371 on the outward facing side. Slits were cut every 3-4 inches so the backing could be continuous and attached in sections.

- For the smaller gaps, BEVA 371 film was attached first to 2-ply translucent goldbeaters skin, cut to shape 2 mm larger than the loss on all sides, and heat activated to adhere to the interior of the hull. The goldbeaters skin was held in place against the hull with a silicone-release paper and blotter paper (for planarity/stiffness) with finger pressure. Since access to the interior was not possible, the film was heat-activated from the front.
- For the larger gap, the backing layer was prepared with aforementioned methods, but with tengucho (thick) paper instead of goldbeaters skin for additional support. The fill was adhered in place with a heat spatula (figs. 45-48).

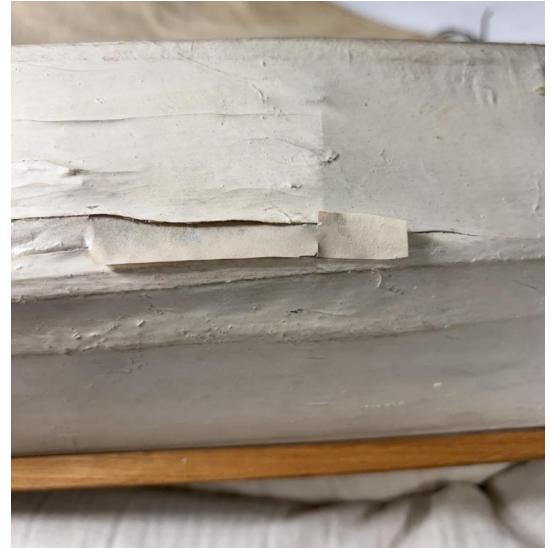
Figure 46. The top edge of the backing layer was tucked behind the hull tear edge.

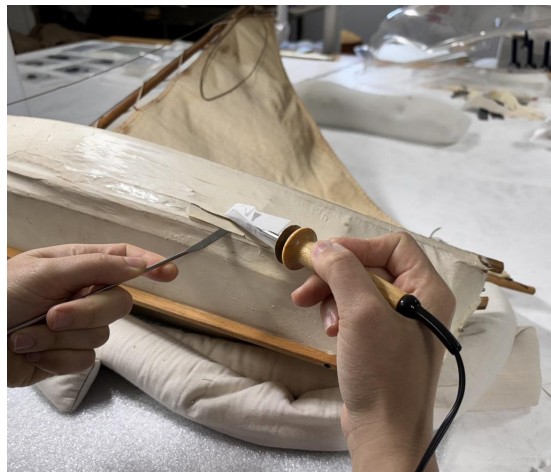
Figure 47. With one hand, a wide-tipped and dull-edged spatula was used to maintain pressure while head activating the BEVA 371 film. The heat spatula was used with silicone release paper folded around the tip.

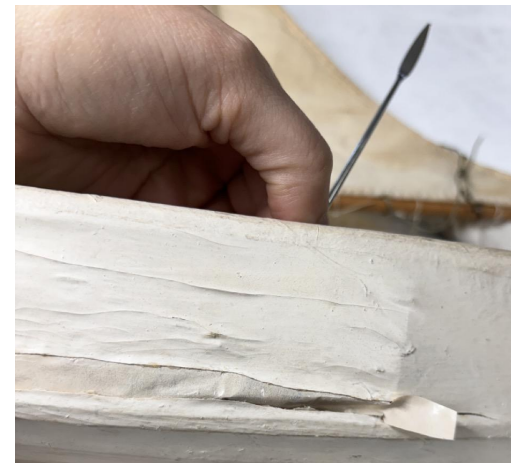
Figure 48. Once the top edge was attached in place, the lower edge was attached in place by maintaining pressure with the wide-tipped, dull-edged spatula between the stringers and side ribs of the umiak. The heat spatula was then used to attach the lower side of the fill in place. This process was repeated for each section of the backing paper.
